# DULVERTON WEIR

**A report by Dulverton Weir and Leat Conservation Group  
on the history, structure and condition of Dulverton Weir**

## Background

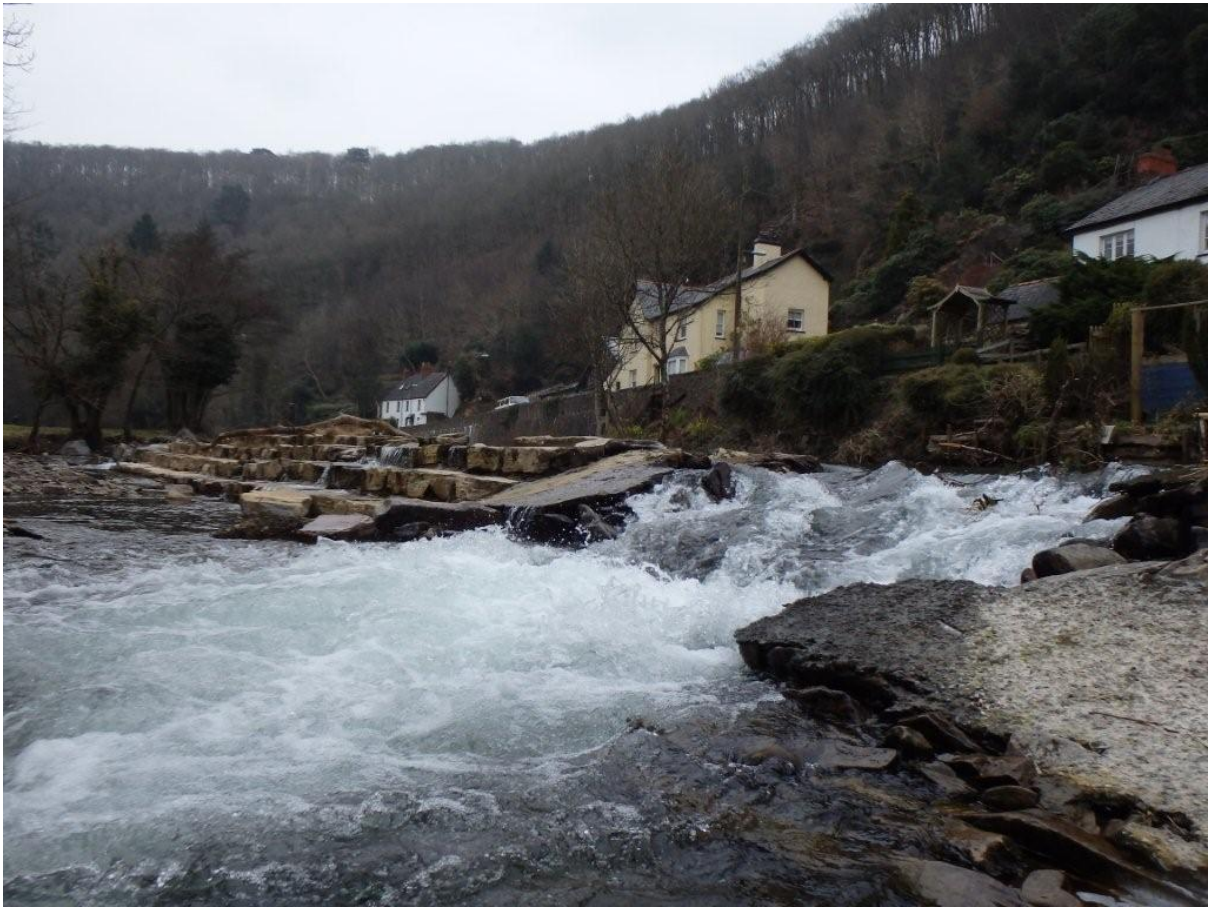
In December 2012, the River Barle flooded, not only causing damage to some properties but also causing two breaches to the crest of the weir, most probably from impact by trees washed down the river. No immediate remedial action was taken with the result that, over a short period of time, the breaches enlarged due to the water flow washing out the exposed substructure of the weir. The photograph on the front cover shows the main breach in March 2013.

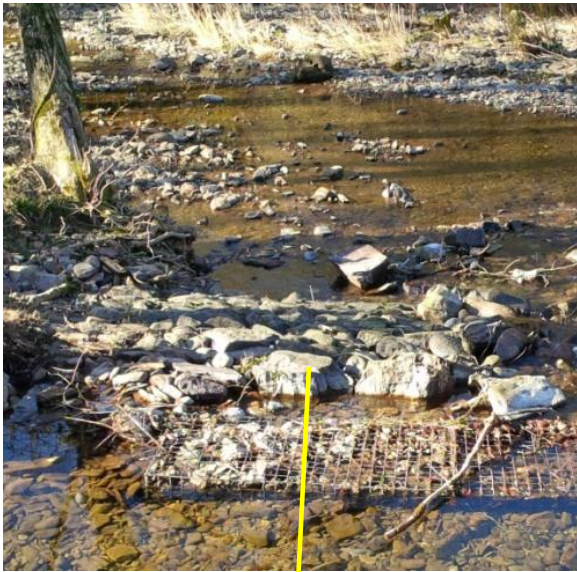
### Southern end of weir (3.7m)

Ancient structure still intact including original 'glacis'.

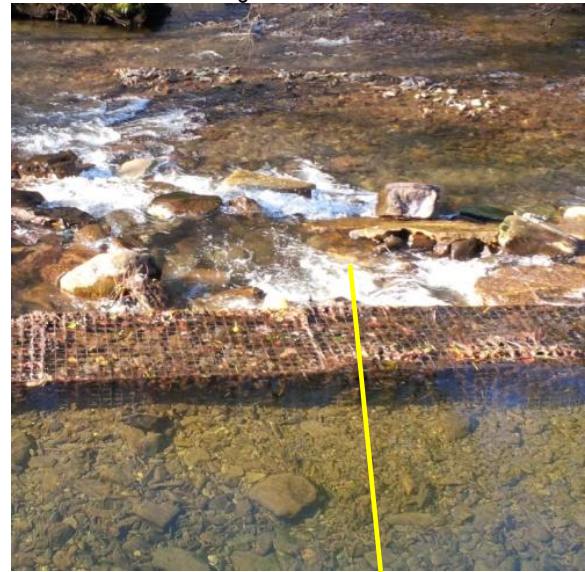
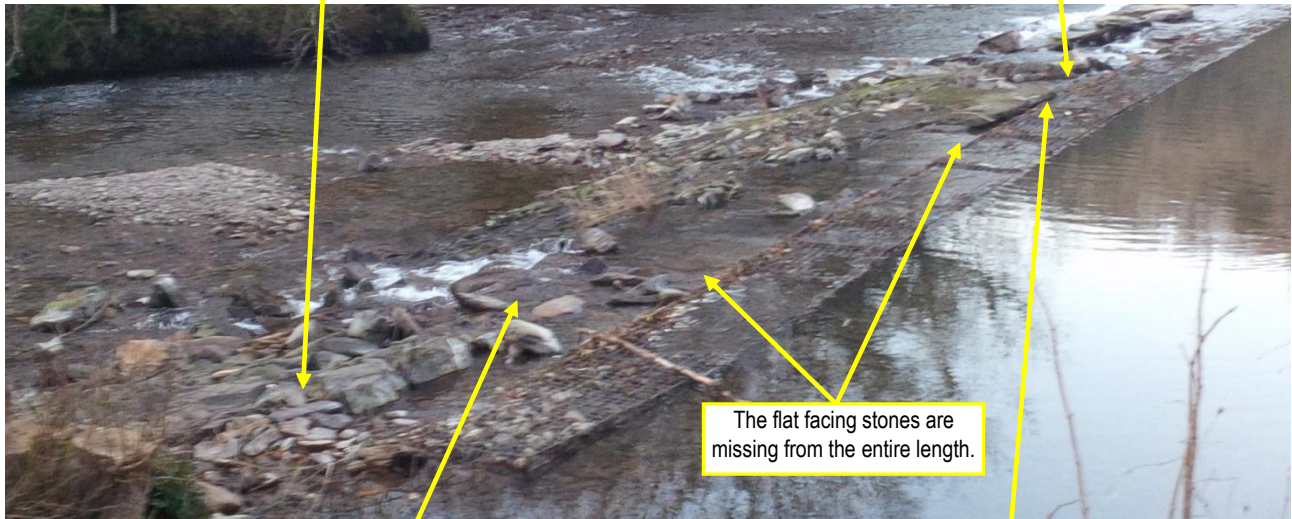
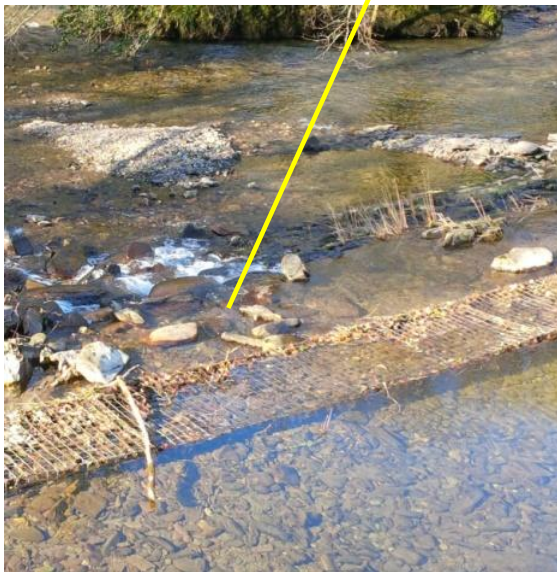
### Large breach from December 2012 (6.7m)

Water has washed through gabions and breach has returned but some original substructure remains below.

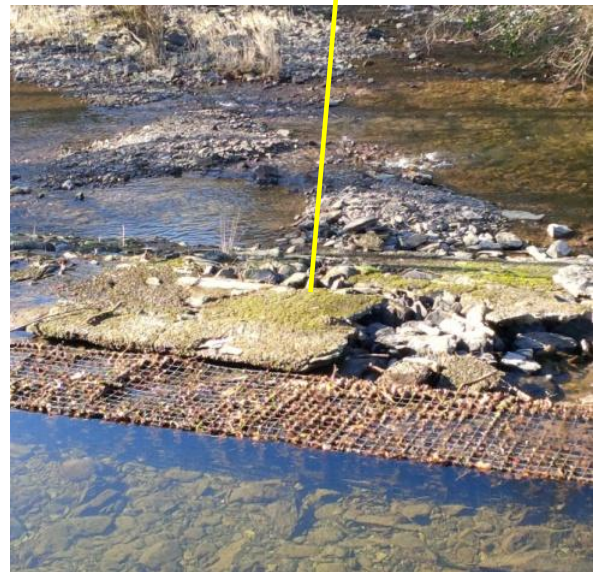
### Small breach from December 2012 (3.2m)

Water has washed through gabions and breach has returned but some original substructure remains below.

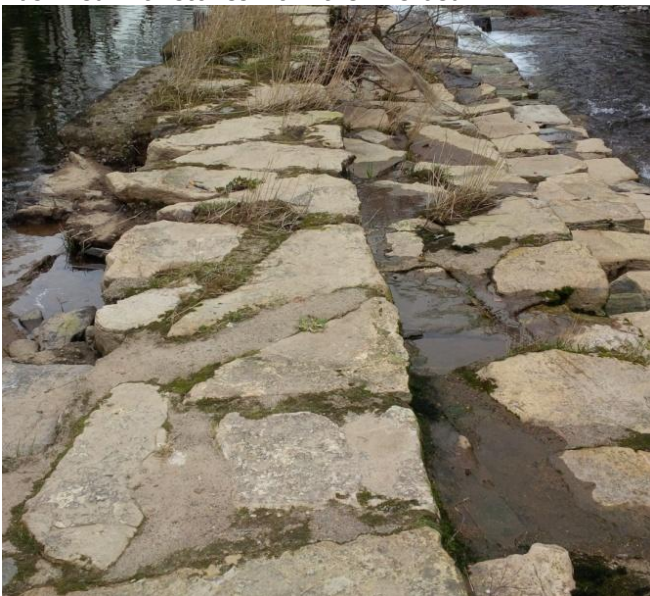
Photo showing the crest in detail. Stones from the front face have been washed away leaving the rest of the structure vulnerable to seepage and further damage. The wet patches behind the crest show that seepage is already present.

1. Stones are missing from the crest.
2. Seepage through the joints of the remaining crest stones will eventually wash out the joints.
3. The void in the core makes the structure inherently weak.
4. There are reports from canoeists of canoes getting "pinned" under the masonry by the fish pass which suggests that the footing has been eroded.

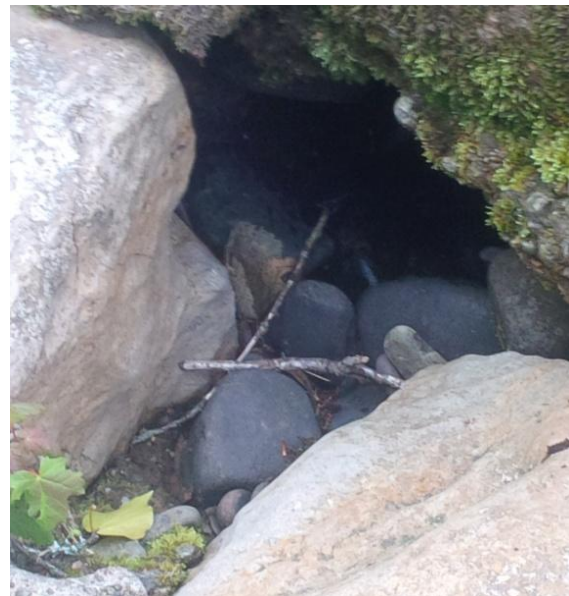
Photo from the stepped side showing a void in the core where some of the river stone infill has been washed away.

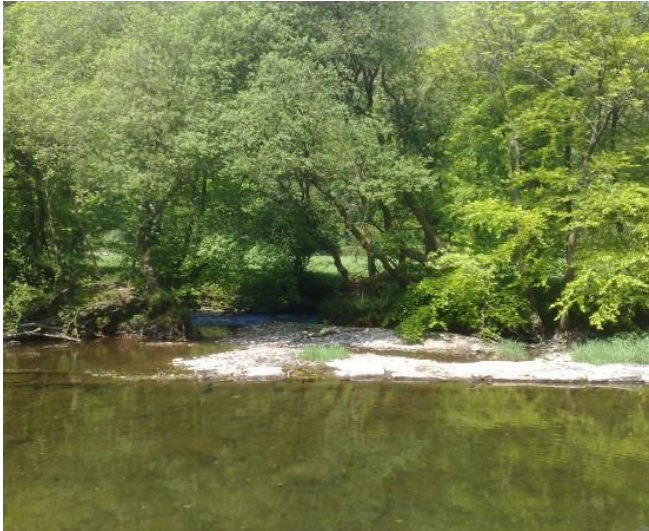
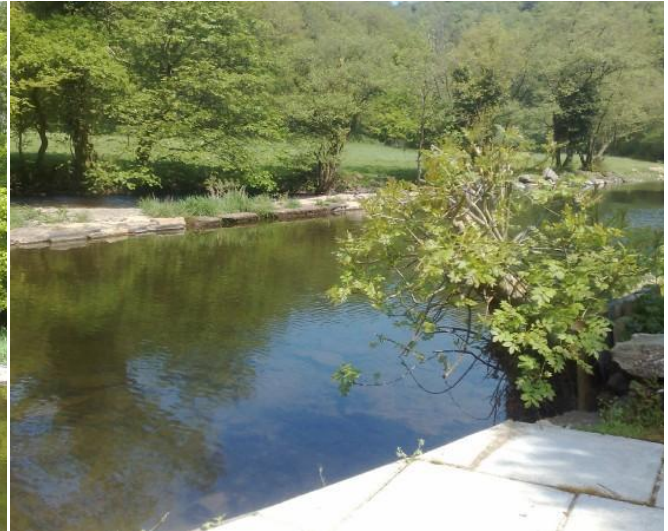
There is a further problem in that the crest of the masonry section is higher than the rest of the weir. The photos below were taken at the same time in October 2008. It can be seen that the masonry part is dry whereas water is flowing over the original structure to the left. This concentrates the flow over the original section rather than spreading the load across the whole of the weir. It is further evidenced by the vegetation growing on the crest. It is the last part to get wet when the river level rises.

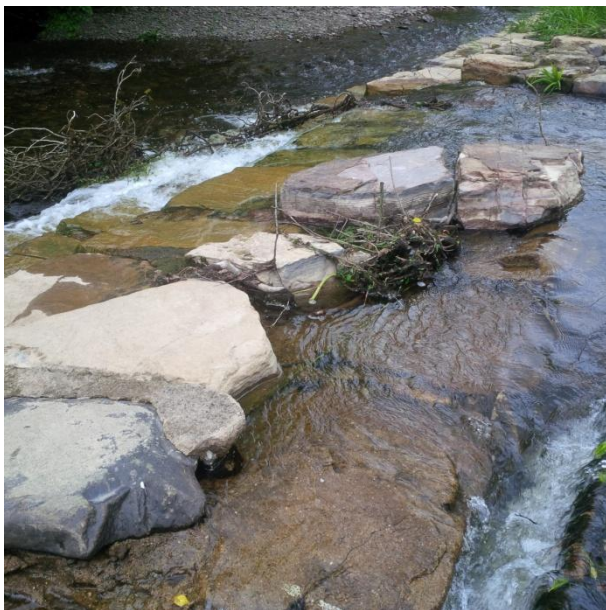
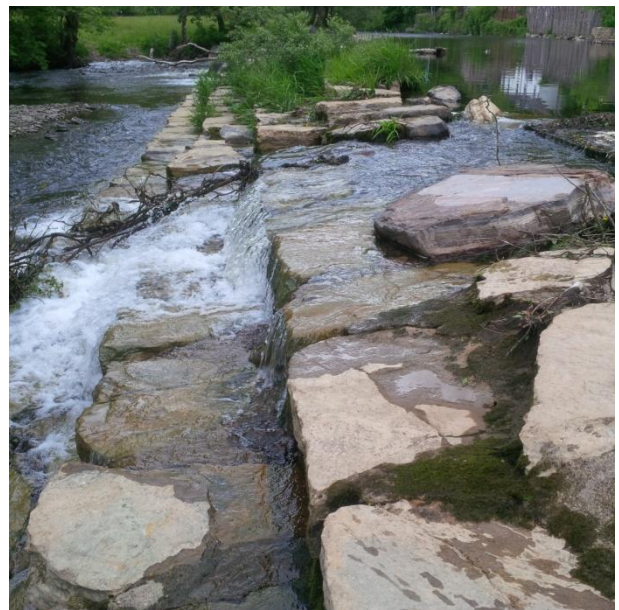
Photos above show the distressed state of this part of the weir in the present day. Stones are washed away from the crest and a new breach has formed.

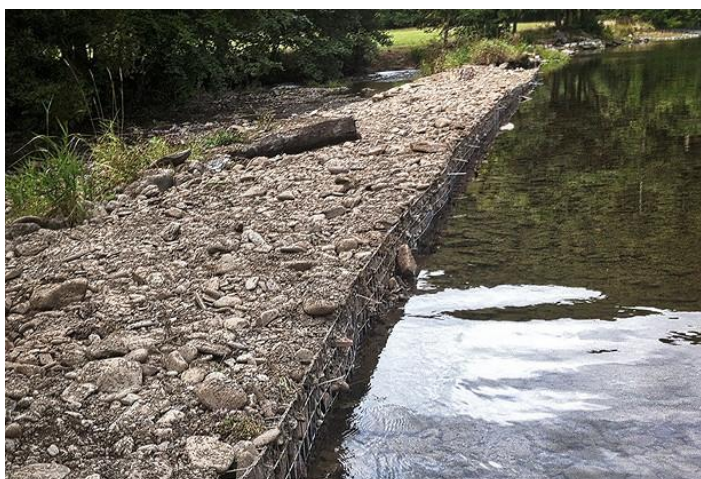
Photo showing the finished gabions

The first time that the river level rose above the gabions, the scalplings were washed away.

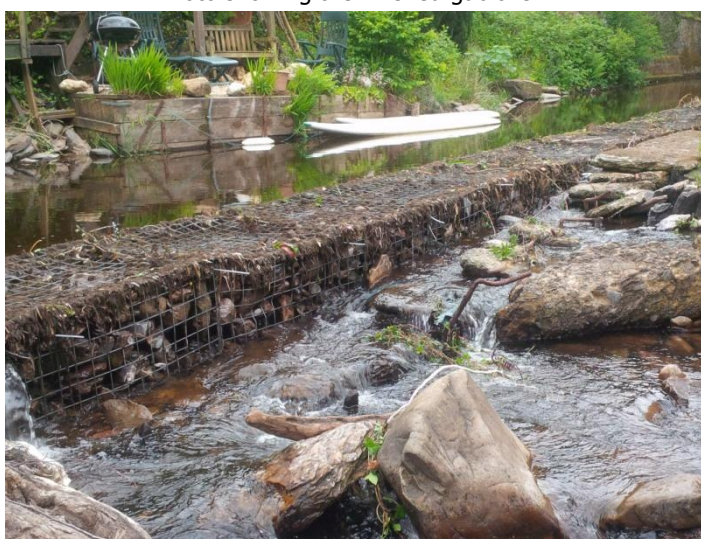
Without a waterproof barrier or membrane, the gabions are porous so that water passes through, washing away the dumped stone in the breach.

Photo showing porosity of gabions as water washes through

Ultimately, the gabion baskets will need to be removed to facilitate permanent repairs to the weir. It is unlikely that the stone can be removed mechanically; it will need to be done by hand.
