DULVERTON TOWN WEIR, EXMOOR HER MEM 21943  
Historical research, recording and assessment  
PROJECT REPORT

DULVERTON TOWN WEIR, EXMOOR HER MEM 21943  
Historical research, recording and assessment

PROJECT REPORT

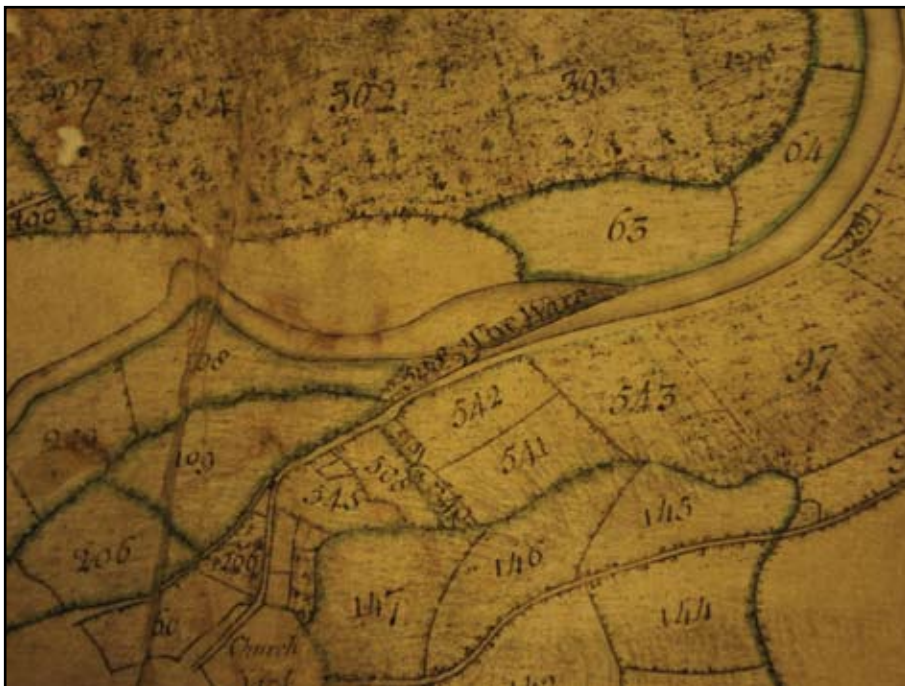
Fig 3 Extract from map of 1790 showing 'The Ware' (SRO DD/X/DL 1/1) (Somerset Archives & Local Studies Service, South West Heritage Trust)

A map of the Sydenham's Dulverton possessions in 1790 is the first time that Dulverton's weir and mills are placed in the townscape (SRO DD/X/DL 1/1). The weir is shown in the same location as the present day structure, running across the River Barle with an overflow or sluice at its south end. It is called 'The Ware' and this name is written across the structure which is shown as a straight line – perhaps the edge of a stone wall– with some shading which could represent the width of the weir or stonework (Fig 3). The relationship between the leat and the weir is not clear on this map, but it probably flowed along the edge of Northmoor Road which was known as the Strand at this time. The leat is shown clearly as a channel which begins at Papermill House (below).

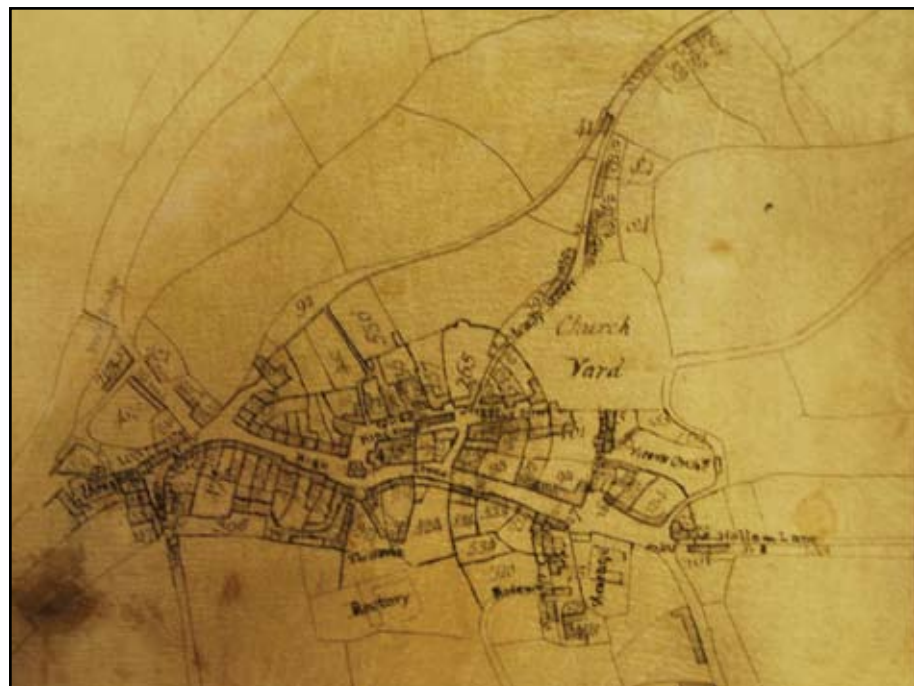
Fig 4 Map of  
Dulverton town  
1790 (SRO  
DD/X/DL 1/1)  
(Somerset  
Archives & Local  
Studies Service,  
South West  
Heritage Trust)

The detailed plan of Dulverton town which forms part of the 1790 survey shows individual building and building plots and further study of this map and the book of reference is needed to clarify the location and function of the mills in the town at this time. The building now called 'Town Mills' is clearly shown, and Lower Mill and the leat outfall into the Barle are also depicted (Fig 4).

Papermill House is clearly shown on the 1790 map as a narrow rectangular building in a plot between Northmoor Road and the leat (Fig 4). Part of the former mill building survives (32 Northmoor Road). It is three-storey, built of stone rubble with timber lintels and small casement windows and probably dates from the 18<sup>th</sup> century (ENPA 2014, 57) (Fig 5).

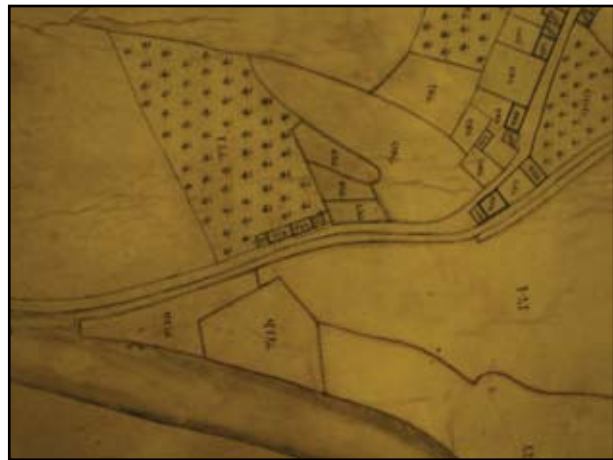
*Fig 6 (Below right) Extract from 1820 map of Dulverton town showing the paper mill (295), south end of weir and beginning of leat (SRO DD/X/DL 1/2) (Somerset Archives & Local Studies Service, South West Heritage Trust)*

The map of the manor of Dulverton in 1820 depicts the town in considerable detail, with its surroundings at a smaller scale. Unluckily, the edge of the detailed town plan ends at the weir, although it does show the beginning of the leat at the south end of the weir (Fig 6). The smaller scale parish map shows the weir as a single scalloped line (Fig 7). The town plan graphically shows the location of two mills – now known as Town Mills and Lower Mill - in the town by the device of drawing a water wheel across the leat (Figs 8 & 9). In the book of reference the mills are called 'Manor Mills,' suggesting that they were all under the same ownership at this time.

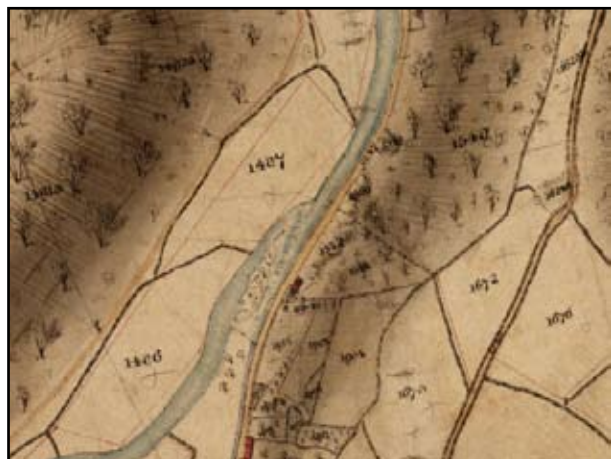
The tithe map (1838) shows the weir as a functioning structure: a straight line runs across the back of the weir, channelling water into the leat. A sluice is marked across the leat and an overflow channel is clearly marked at the south end (Fig 10). Blue lines indicate water flowing across the weir and an island in front is the forerunner of the five small islands shown on the 1<sup>st</sup> edition map (Fig 11).

*Fig 10 (below) Dulverton tithe map 1838 (SRO D/D/Rt/M/274) (Somerset Archives & Local Studies Service, South West Heritage Trust)*

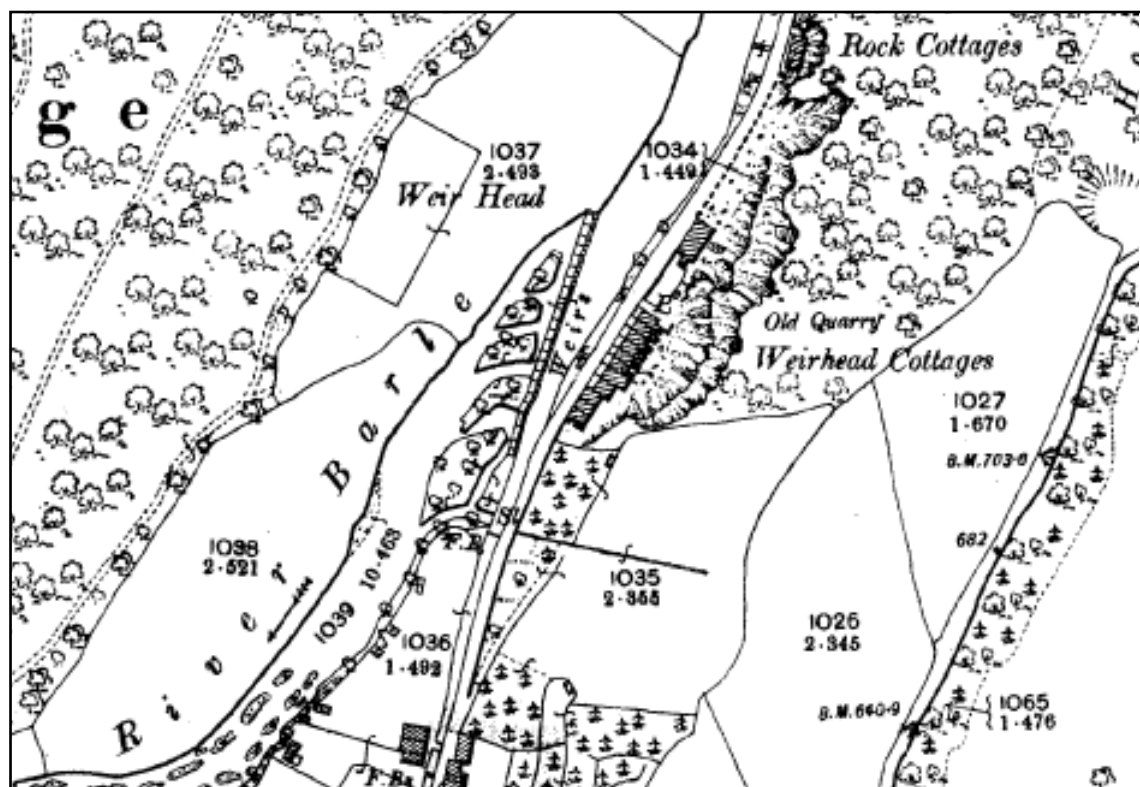
Fig 12 (above) Extract from OS 2nd edition map (1902)

The OS 2<sup>nd</sup> edition map of 1902 shows that the leat has been modified since the 1889 map – this is probably a phase of repair and rebuilding. A narrow wall lies on the upstream side of a structure built of 23 sections, some 95m long, 5m wide with a sluice to the south (Fig 12). A photograph taken in the early 20<sup>th</sup> century shows the weir from the downstream side. Lines of vegetation suggest that the sectional construction shown on the OS maps and the figure gives an idea of the height of the weir: about 1.5m (Fig 13).

The area was very overgrown during the site visit (Fig 27) but the 2<sup>nd</sup> edition OS map shows very clearly how the weir functioned at its SW end, with a substantial spillway to take excess water back into the river adjacent to the sluice at the leat. A channel observed by the DWLCG but inaccessible at the time of the site visit probably marks the front of the weir as shown on the OS 2<sup>nd</sup> edition map (Fig 12).

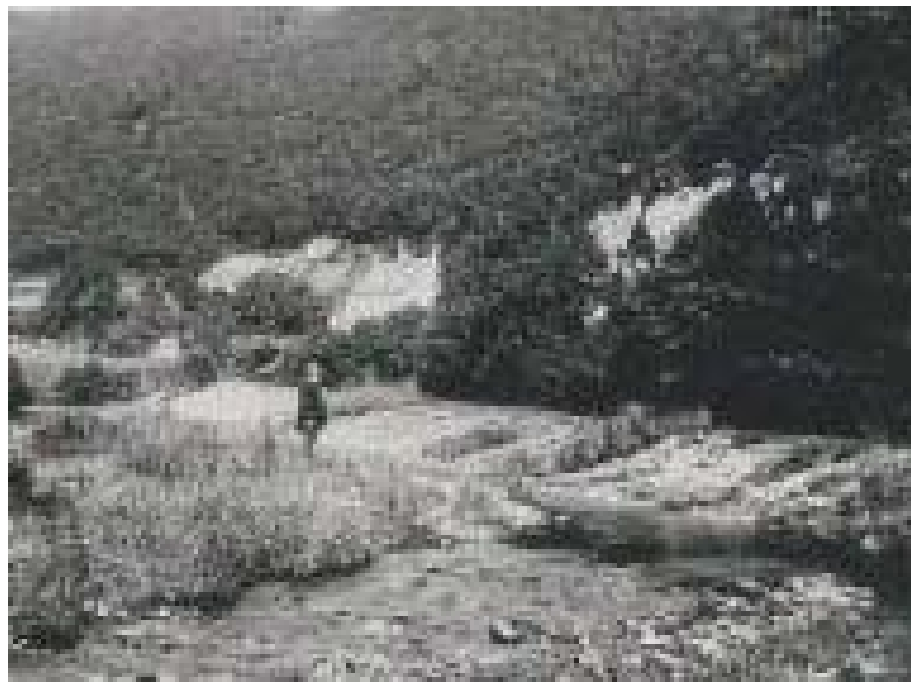
*Fig 13 The weir c 1930 (West Somerset Photographic Archive, West Somerset Museum Rural Life, Allerford)*

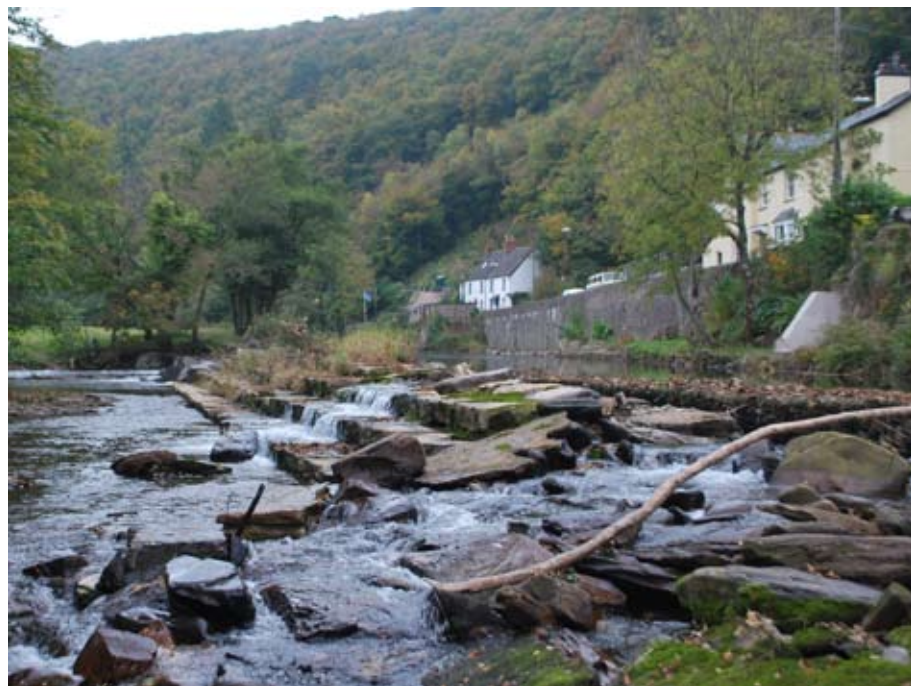
At the NE end a fish pass, c 14m long and 6m wide, constructed of boulders in 1993, is visible but access to it was not possible (Fig 15)

*Fig 15 The fish pass and stepped masonry section of the weir (Hazel Riley)*

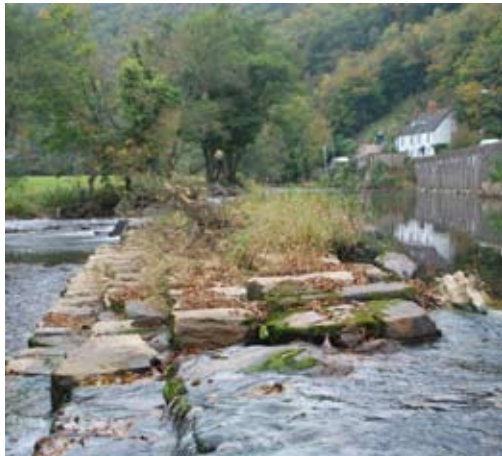
Some 24m of the weir were rebuilt with sandstone blocks over a stone rubble core in 1995 and 2000. The masonry is visible but access to it was not possible (Figs 16 & 17).

*Fig 16 (above) Stepped masonry section of the weir (Hazel Riley)*

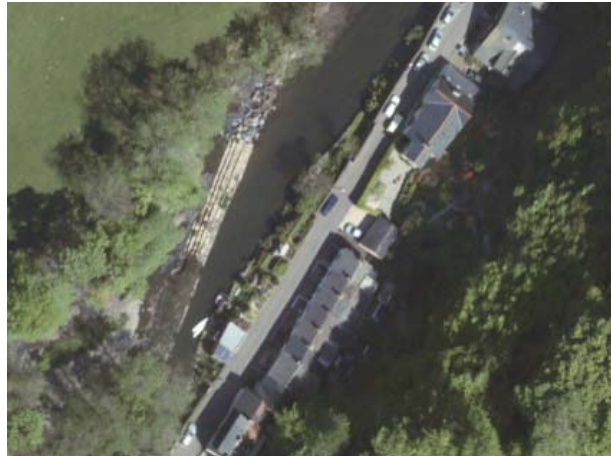
*Fig 17 (above right) The weir in 2010: stepped masonry section in centre, fish pass to top and historic weir above the island (ENPA)*

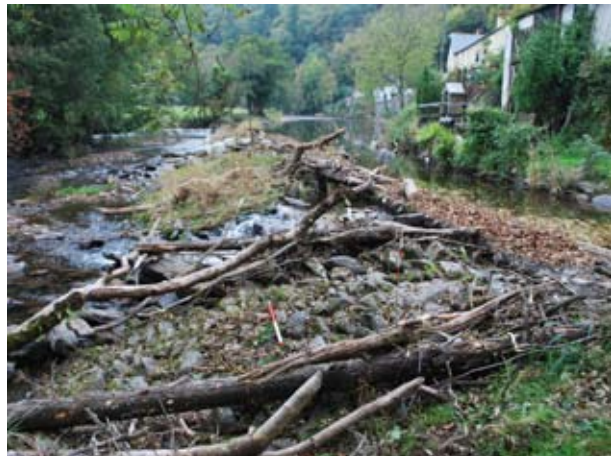
Some 20m of the structure, between the island and the SW end of the stepped masonry weir, is built of stone which has been capped with concrete in places. This capping has failed in a number of places. Several wooden stakes are visible towards the front of the structure when the river level is low and structural features within the stonework are visible. A well preserved section of the weir at the NE end of the island is some 4.4m NE/SW by 5m NW/SE (Fig 14,A; Fig 18). It comprises a sloping embankment of carefully placed water worn cobbles which probably originated from the river bed (Fig 19). Large upright stone slabs form the front face of the weir (Fig 20).

*Fig 18 (right) The historic weir (1m scale on section A) (Hazel Riley)*

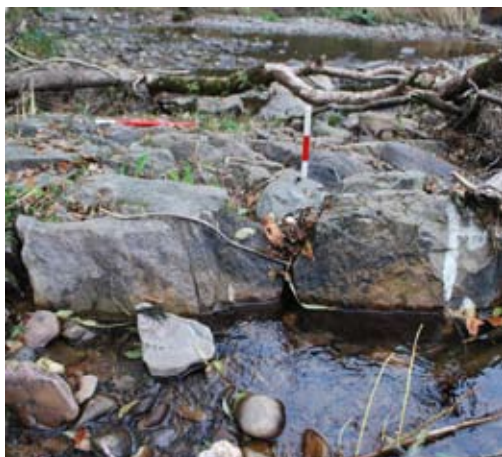
*Fig 19 (bottom right) Section A of the historic weir from the west (downstream) side (1m & 0.5m scales) (Hazel Riley)*

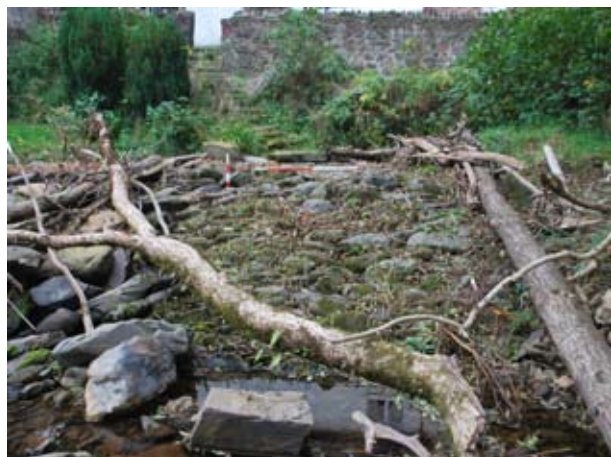
*Fig 20 (below) Upright stones at the front of the weir (0.5m scale) (Hazel Riley)*

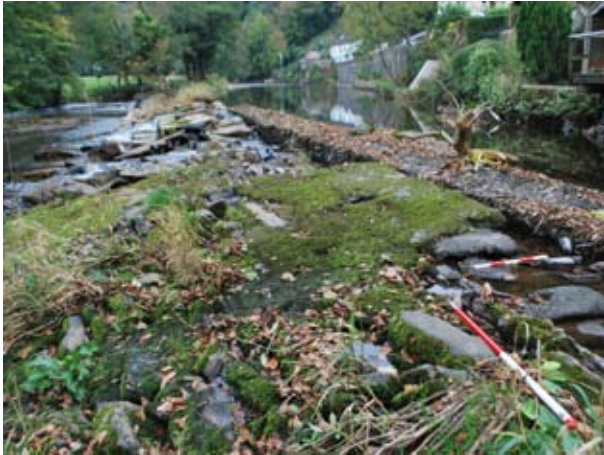
At the foot of the weir some carefully placed stone slabs are visible below the water level (Fig 21).

Fig 21 (above) Stone slabs at foot of weir below water level (1 m scale) (Hazel Riley)

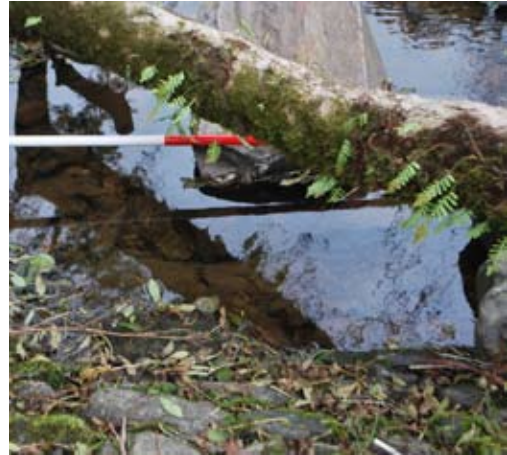
To the NE of a substantial breach in the weir is a further section of well preserved historic weir (Fig 14, B). It is 10m NE/SW by 5-7m NW/SE and is mostly capped with concrete but where this has failed details of the historic structure are visible (Fig 22). Several upright stones are probably part of the historic weir structure and would correspond with its depictions on the OS 1<sup>st</sup> and 2<sup>nd</sup> edition maps (Figs 23; 11 & 12).

Fig 22 (above left) Section B of historic weir. 1 m scale by upright stones of front face (Hazel Riley)

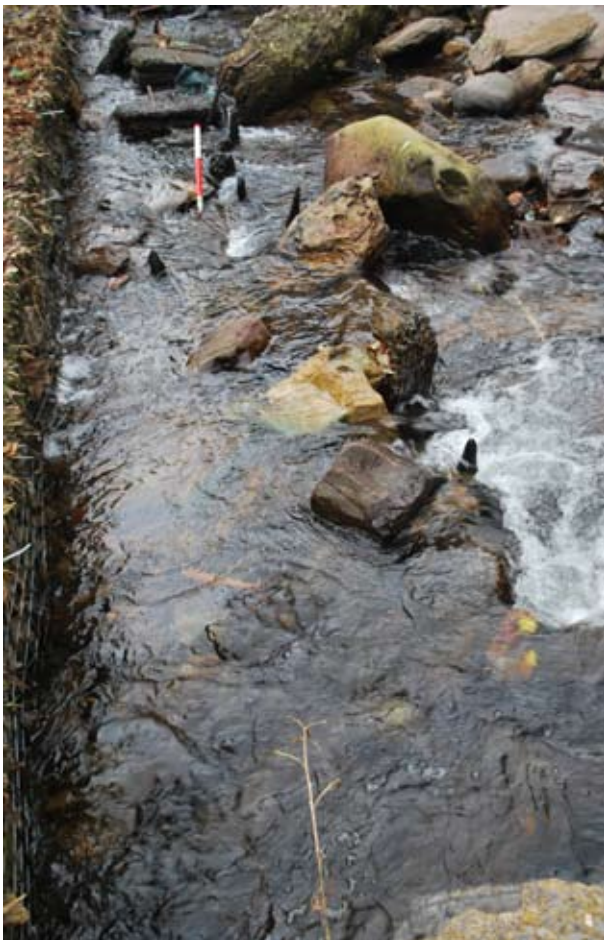
Fig 23 (below) Upright stones forming front face of historic weir, section B (1 m scale) (Hazel Riley)

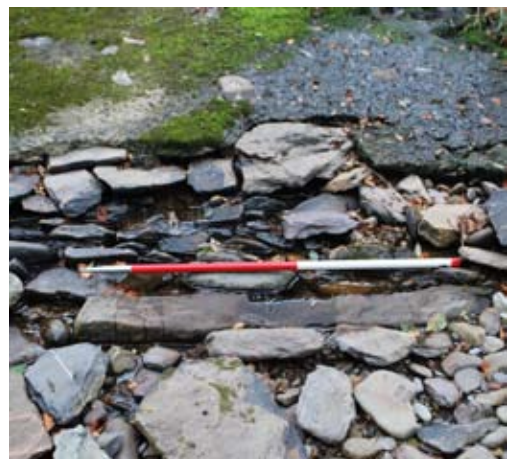
Fig 24 (left) Six stakes in the historic weir (Hazel Riley)

A second breach has washed out some of the structure at the SW end of the stepped masonry structure and here 6 stakes are visible when the river level is low (Figs 24 & 25). These are similar to the oak stakes recovered from the repairs in 2014 (above); a stake found on the surface of the weir was oak and some 0.6m long (Fig 26).

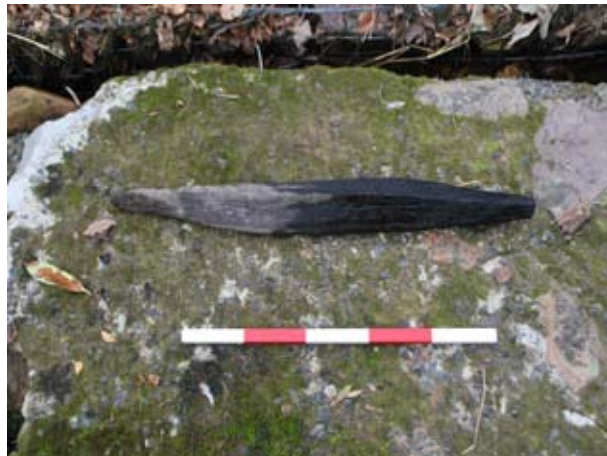
*Fig 25 (below) Detail of the oak stakes  
(Hazel Riley)*

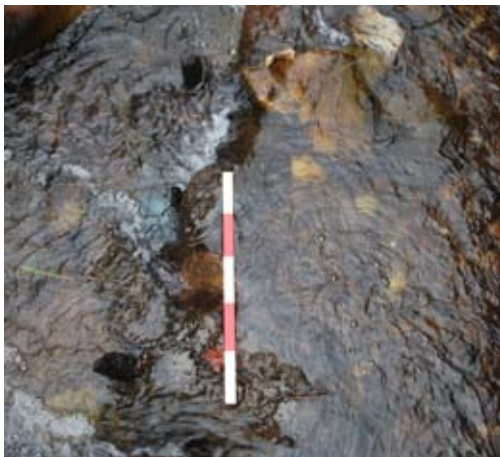
*Fig 26 (right) Oak stake found on the weir  
surface (0.5m scale) (Hazel Riley)*

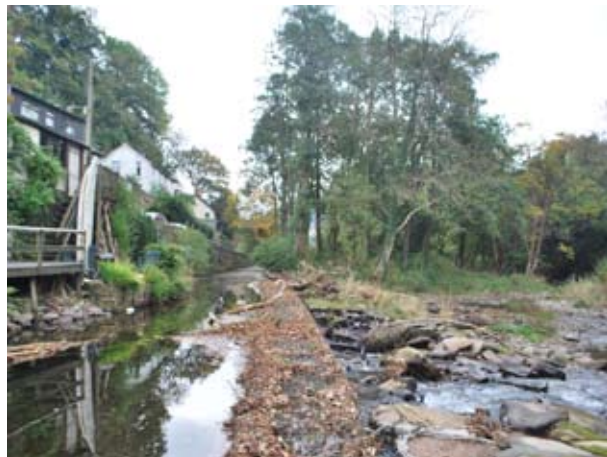
*Fig 27 (below right) Looking SW down the  
weir pool with the island to the right of the  
photograph (Hazel Riley)*

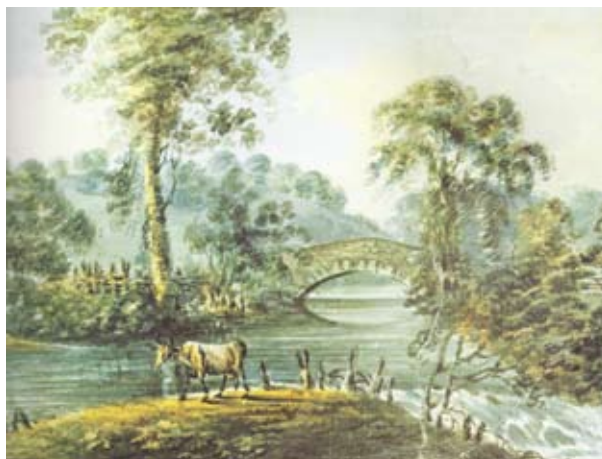
*Fig 28 Swete's 'Bapel's Bridge 1796, showing a weir for a grist mill on the River Kenn (Gray 1999, 23)*

A further source for the character of historic weirs which has been largely neglected are paintings and prints, in particular the collection of watercolours by William Payne (Devon Local Studies Library [www.devon.gov.uk/localstudies](http://www.devon.gov.uk/localstudies)) and John Swete (Gray 1997; 1998; 1999; 2000). Rivers and picturesque mill buildings were favoured subjects and William Payne's painting of Staverton Weir shows a stone weir with wooden stakes below it, suggesting that the stakes had been replaced by a stone structure by the later 18<sup>th</sup> century. John Swete usually painted rivers in full flow, so that most of his studies of weirs have the appearance of small waterfalls. Dunsford Mill Weir is described as 'divided ledges of stones rudely piled', and a painting of the weir at Otterford clearly shows a stone weir with the mill leat behind (Gray 1998, 42). Another of Swete's watercolours shows a weir constructed of stones and wooden stakes at Bapel's Bridge on the River Ken – this is dated 1796 and appears to be very similar to the surviving historic fabric at Dulverton. The weir on the River Ken supplied water for a grist mill in use in the late 18<sup>th</sup> century (Gray 1999, 23) (Fig 28).

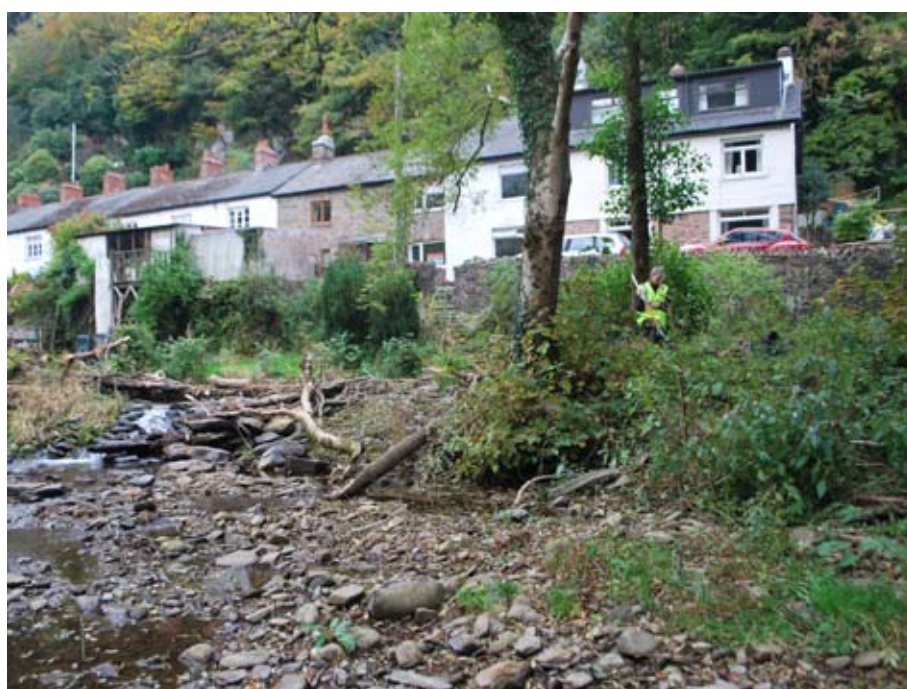
*Fig 29 The historic weir and the island (Hazel Riley)*
