RIVER BARLE @ DULVERTON: RIVER JELLY LICHEN SURVEY REPORT

April 2014

1. Purpose: This is a brief note to Atkins following a request to check a site on the River Barle (Dulverton, West Somerset) for the presence/absence/locations of River Jelly Lichen *Collema dichotomum*. The lichen is a protected species (schedule 8 of the WCA 1981), and as such damage to any populations has to be avoided unless there are extreme mitigating circumstances. The reason for needing to know the whereabouts of the species in the river at Dulverton was because an historic weir has been breached, and there is a desire to restore it without impacting the River Jelly Lichen population in any way.

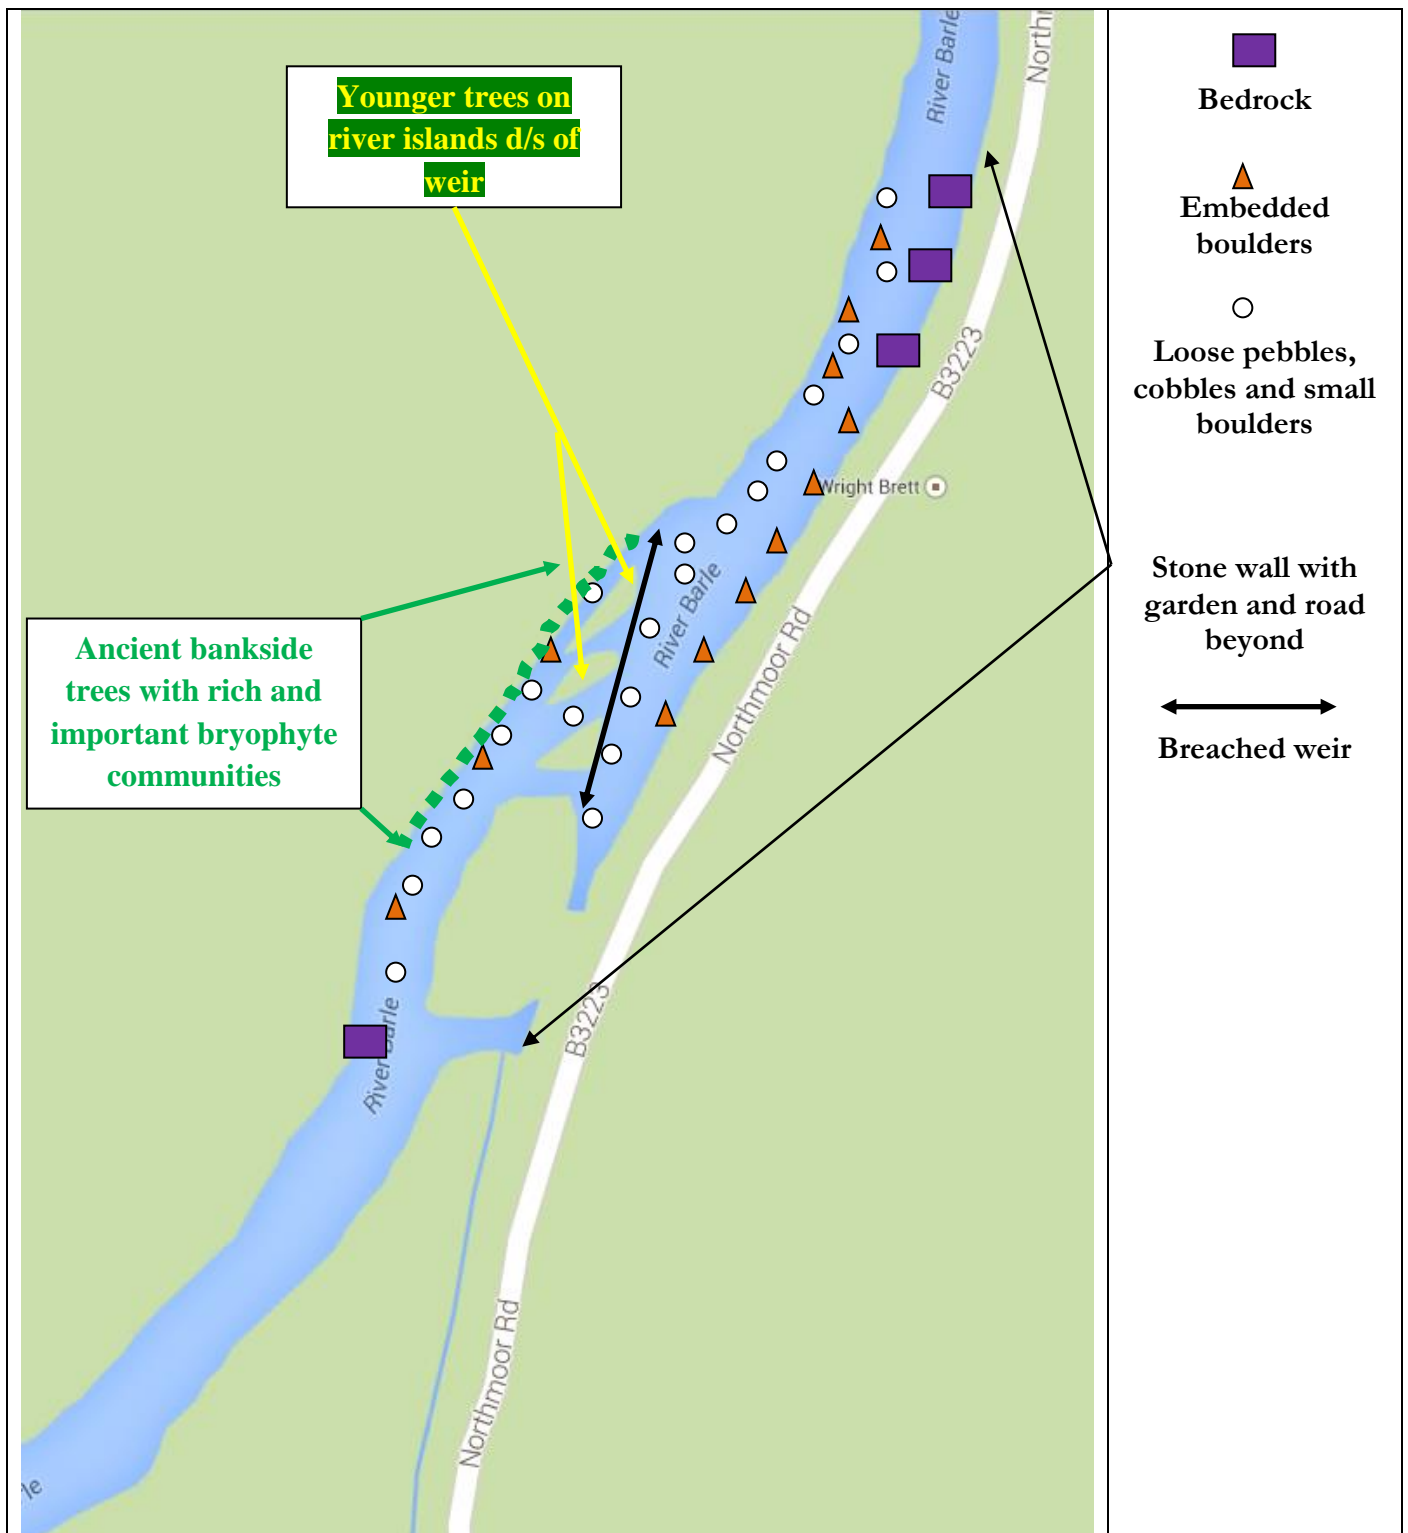
Figure 2. Summary of key physical characteristics of the site.

3. Over-view of site characteristics: Figure 2 summarizes the site characteristics, with images presented in Appendix 1 illustrating most of the main features visually. In summary the relevant characteristics were:

- The weir has several breaches, and downstream of this three small river islands have been developing for many decades;
- Flow between the three islands is shallow and over very unstable cobbles and pebbles;
- The larger channel immediately upstream of the grill to the mill leat has a more stable flow and bed, but this too is dominated by pebbles and cobbles;
- Downstream of the weir flow is directed towards the right bank where some larger boulders are present, and some are firmly embedded;
- Opposite the main outfall at the southern end there is some bedrock on the right side of the channel, with the usual loose cobbles on the left side;

- A line of mature trees along the right bank downstream of the weir supports a good bryophyte community, with abundant *Porella pinnata* present to approximately 1m above low-flow water level (see Appendix 2 showing national distribution);
- Upstream of the weir the water velocity is generally sluggish (would be ponded when weir restored) for over 70m upstream;
- The right (west) side of the channel is dominated by unstable cobbles and the deeper left side (east) dominated by larger boulders;
- Around 75m from the weir there is a faster-flowing, shallower section with bedrock present along the left side of the channel.

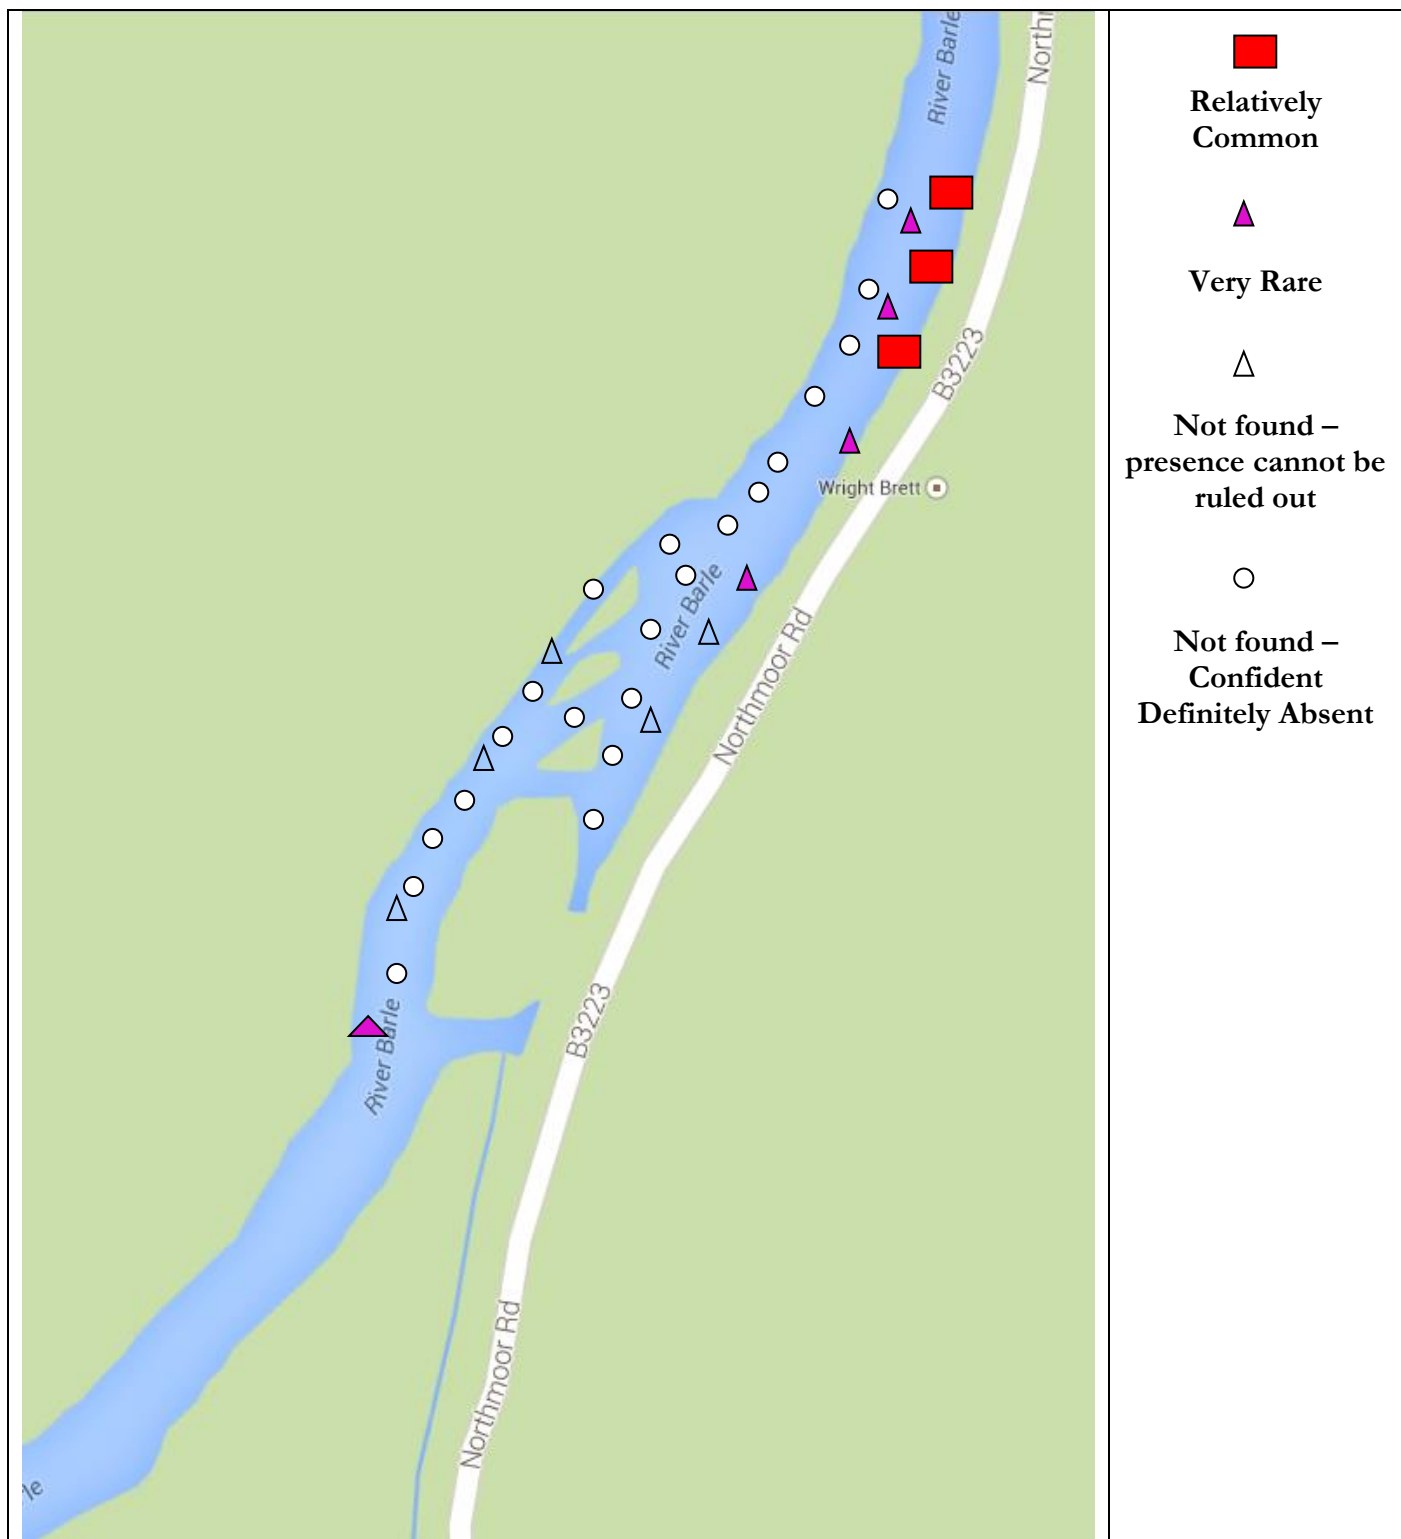
Figure 3. Result of River Jelly Lichen survey.

4. Summary of survey for River Jelly Lichen: Figure 3 below shows where the lichen was found, and where it was not. There is reasonable confidence in the findings since the locations where RJL was found coincide with where the most stable areas of bed are located (bedrock and embedded boulders) and it was never found on the loose cobbles. The loose cobble areas also had least moss and algal cover, and so if the lichen had been present in such areas it would have been easier to see. The only area where it was reasonably common was the only location where habitat was optimum – upstream on the left side of the channel c75m from the weir.

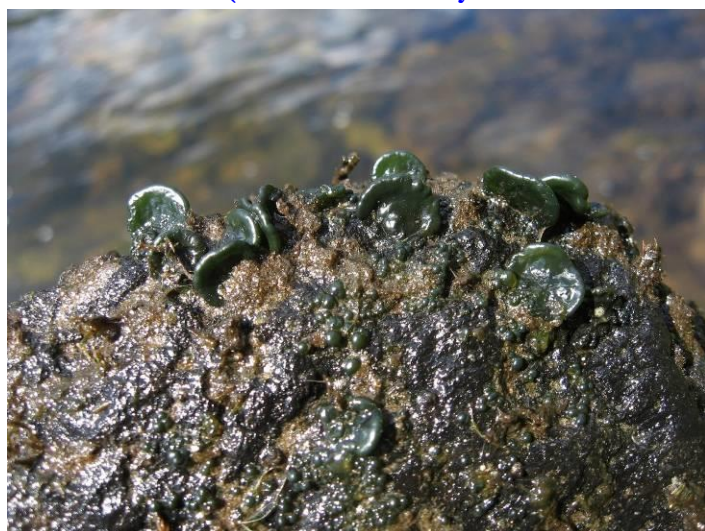
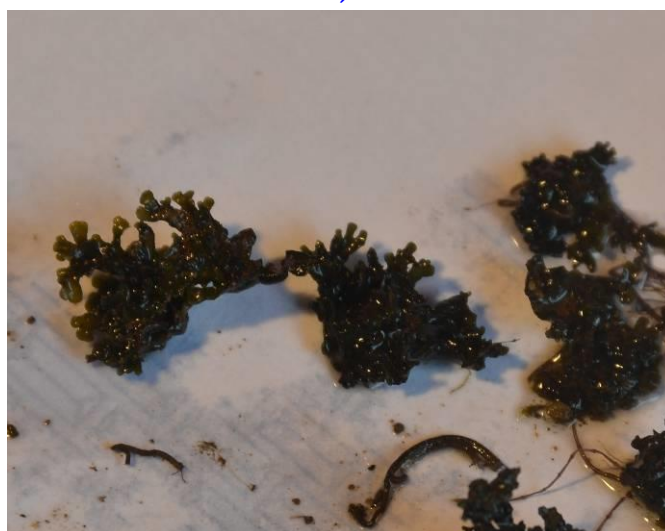
Figure 4. Image of *Nostoc parmelioides* (left) alongside specimen of RJL (right) collected at the site.

Due to the extent of algal cover, and water depth, it was impossible to photograph the lichen in situ. A small amount of material was collected as voucher specimens (sent to Atkins) and a photo in Figure 4 shows this material for reference to accompany this report.

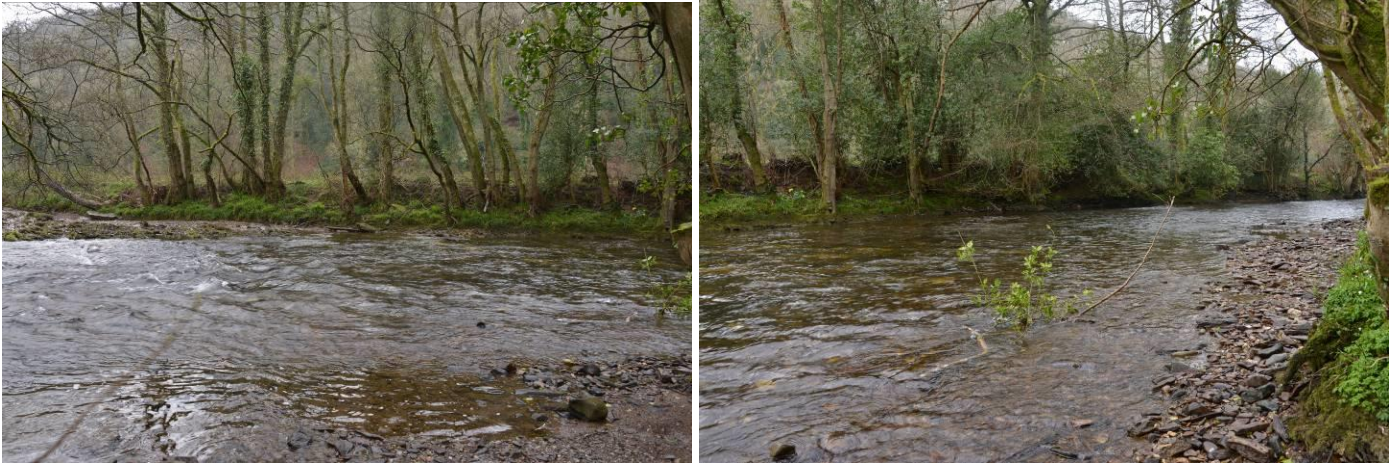
Images of Barle at downstream end of survey site where bed predominantly composed of loose cobbles but with a bedrock outcrop at the downstream limit (image on left)

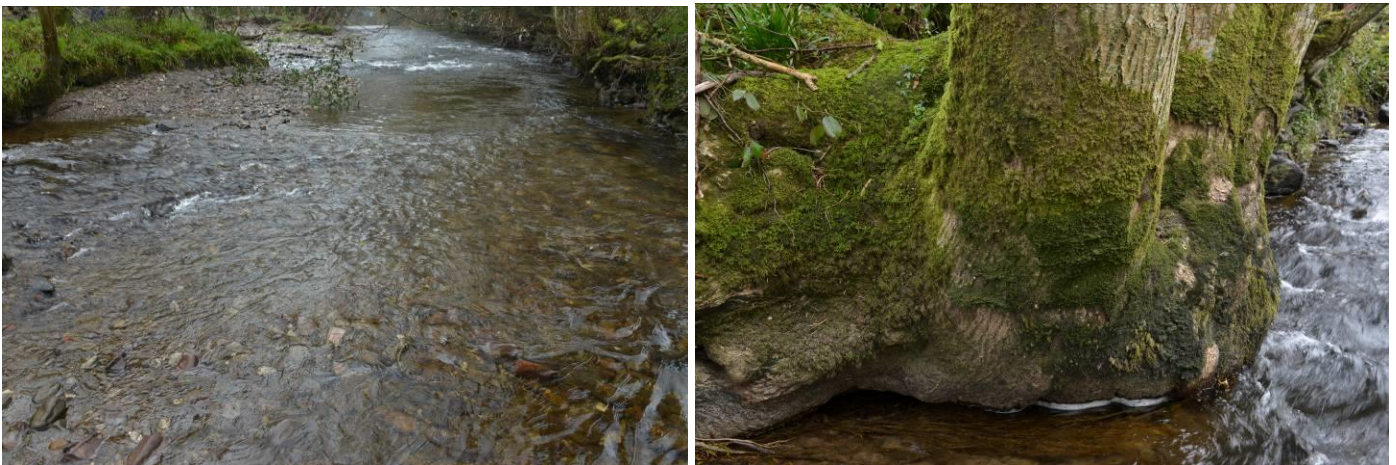
Typical loose cobbles in channel by the islands and the tide-line of *Porella* on bankside trees downstream of the weir

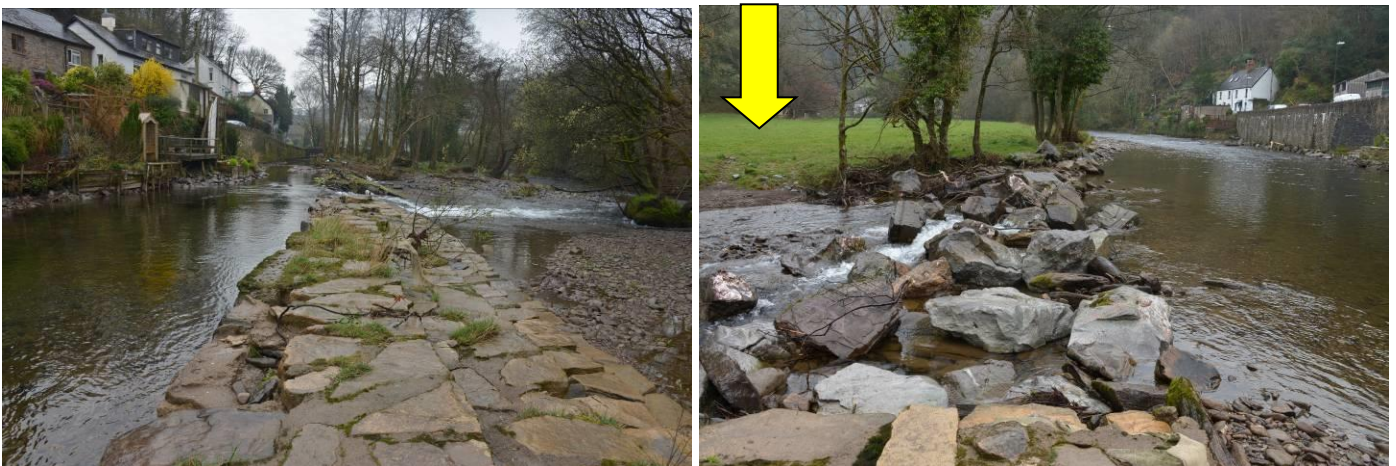
Views looking along the weir. On the left looking downstream – note unstable cobbles and shallow water d/s of the weir. On right looking upstream – again note very unstable cobble bed – both upstream and downstream is totally unsuitable for RJL along entire length of the weir. Yellow arrow shows suggested access point for machines and materials

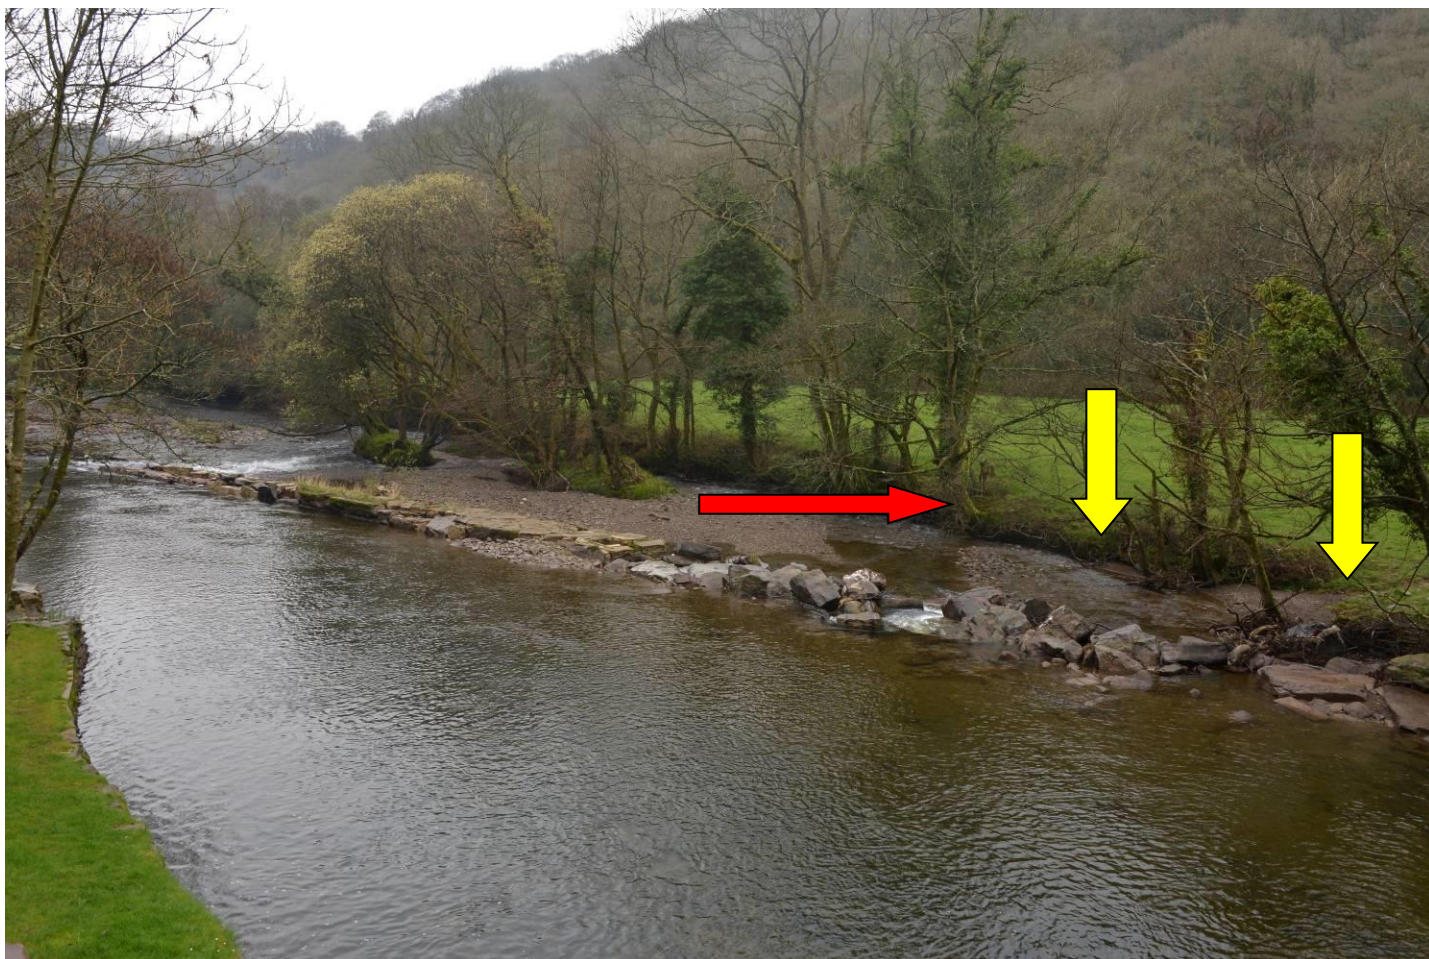
View looking along top end of weir showing: unsuitable RJL substrate; start of important bryophyte communities on bankside trees → and recommended acceptable access points ↓

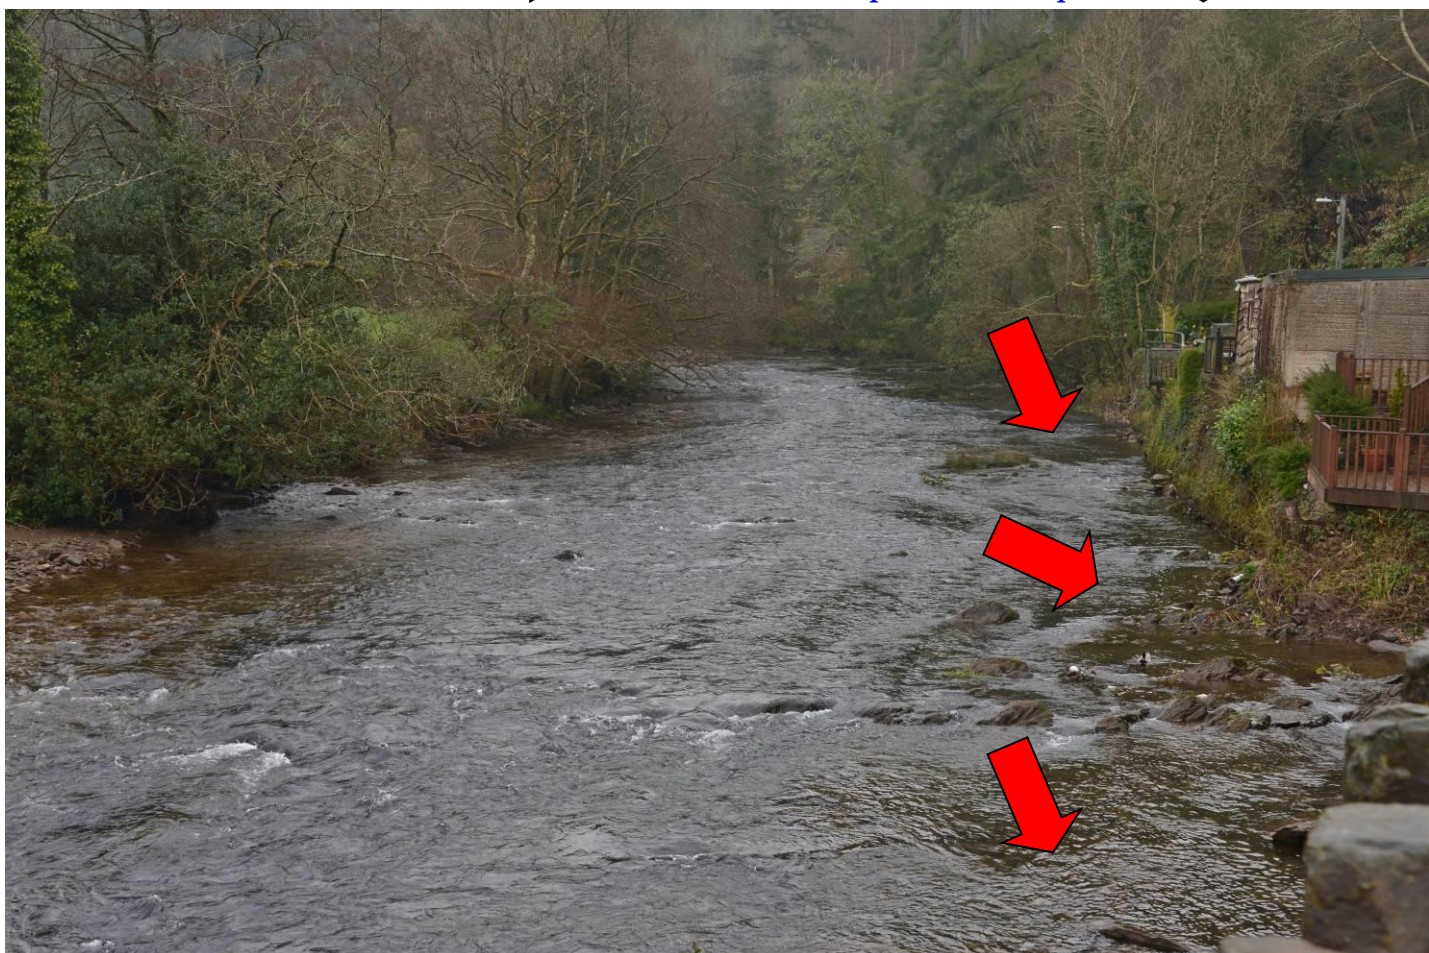
View of upstream survey limit (c75m u/s weir) showing only location where RJL found commonly
