BULLETIN

No. 149

April 2022

Dulverton Weir

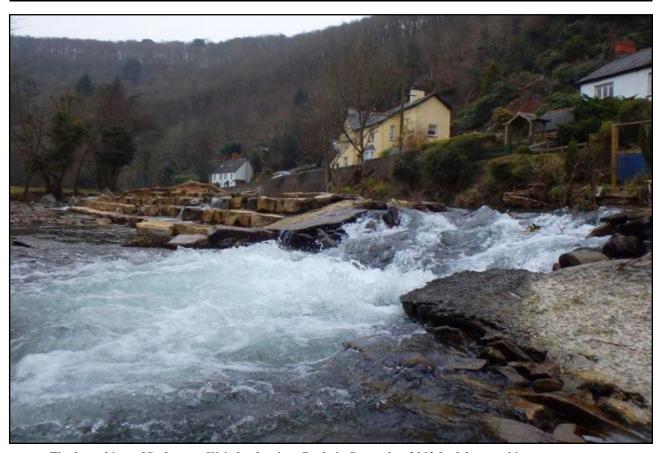
The breaching of Dulverton Weir by the river Barle in December 2012 had far-reaching consequences.

In December 2012 the River Barle flooded, not only causing damage to some properties but also causing two breaches to the crest of the weir, most probably from impact by trees washed down the river. No immediate remedial action was taken with the result that, over a short period of time, the breaches enlarged due to the water flow washing out the exposed substructure of the weir. An attempt to temporarily stop up the breaches using sand-filled 'dumpy bags' resulted in failure as the river simply washed them away.

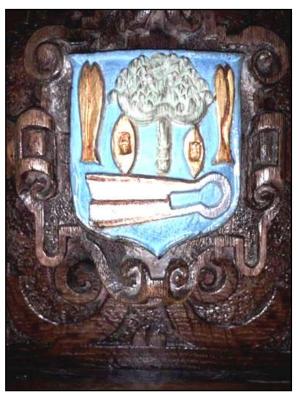
Escutcheon of the Guild of Weavers, Tuckers and Shearrmen showing the tools of their trades

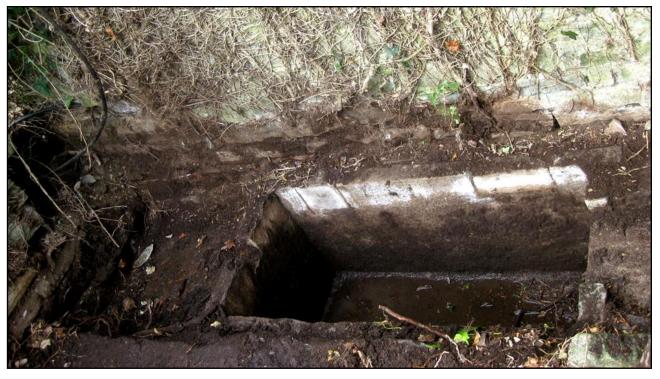
some buried evidence (2-inch iron pipes) that these tanks also fed troughs for wintered livestock as well as catering for human needs. The tanks were vulnerable to birds or vermin falling in and, on their removal in 1980, I discovered the tank outlet pipe filter *(right)* made of lead!

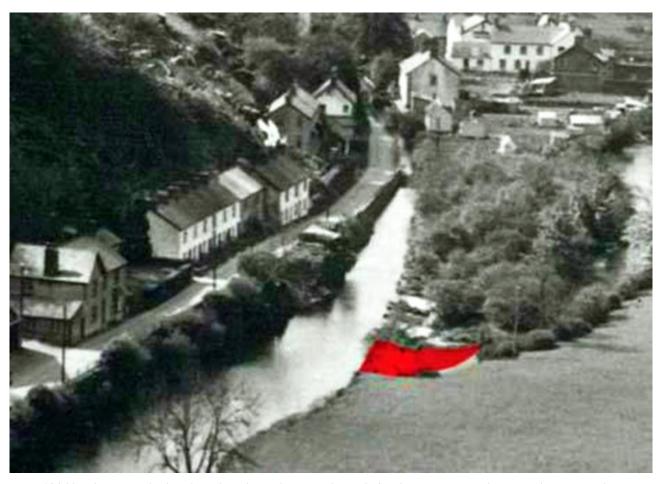
1930's photograph showing that the weir started much further upstream than can be seen today.

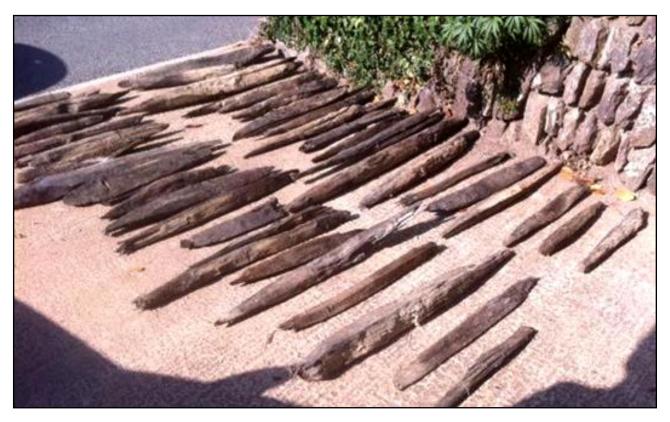
The full cohort of stakes recovered from the weir

Two stakes, probably from the same tree, were identified to have been felled around 1784, suggesting a phase of construction or repair around this time. Three other stakes, identified as having been felled around 1803, together with consistent felling-date ranges produced from all the other stakes, provided strong evidence that a further major phase of construction or repair of the weir occurred around 1803.

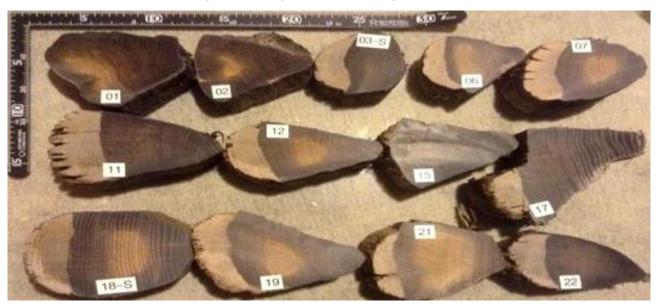
Thirteen sub-sections of stakes that underwent dendrochronological analysis

While these results identified two likely phases of construction or repair, weirs are often periodically damaged by floods and therefore the stake dates may not necessarily be as old as the weir itself. Additional analysis of stakes from other parts of the weir may identify other earlier phases of construction or repair.

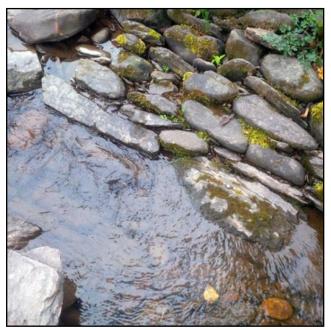
Flat stones at the "toe"

- The "toe" of the weir a step cut in the riverbed for the structure to compress against.
- Oak stakes hammered into holes drilled into the rock bed of the weir to prevent horizontal slippage.
- Facing stones large flat stones laid on edge across the upstream face of the weir to prevent seepage.
- Substructure large random sized stones laid from the toe going forwards to support the stakes horizontally and the glacis stones vertically.
- The glacis rounded edge stones laid from the toe going forwards to form a slope from the crest of the weir down to the toe (approximate angle 20°).

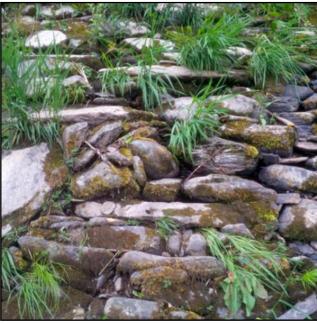
Rounded stones of the "glacis"

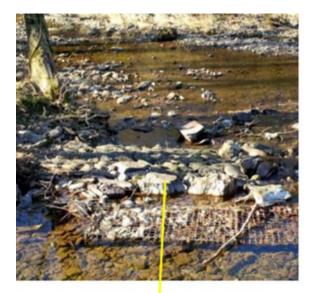
Large breach from December 2012 (6.7m) Water has washed through the gabions and the breach has returned but some original substructure remains below

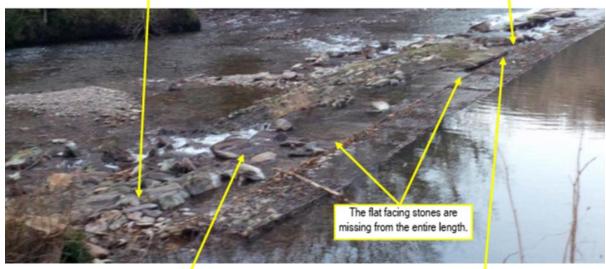
Small breach from December 2012 (3.2m) Water has washed through the gabions and the breach has returned but some original substructure remains below

The first time that the river level rose above the gabions, the scalpings were washed away. Without a waterproof barrier or membrane, the gabions are porous, so water passes through, washing away the dumped stone in the breach. Ultimately, the gabion baskets will need to be removed to facilitate permanent repairs to the weir. It is unlikely that the stone can be removed mechanically; it will need to be done by hand.

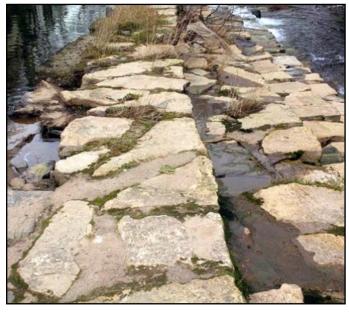
Crest of the weir showing that stones from the front face have been washed away leaving the rest of the structure vulnerable to seepage and further damage. The wet patches behind the crest show that seepage is already present.

- Stones are missing from the crest.
- Seepage through the joints of the remaining crest stones will eventually wash out the joints.
- The void in the core makes the structure inherently weak.
- There are reports from canoeists of canoes getting 'pinned' under the masonry by the fish pass which suggests that the footing has been eroded.

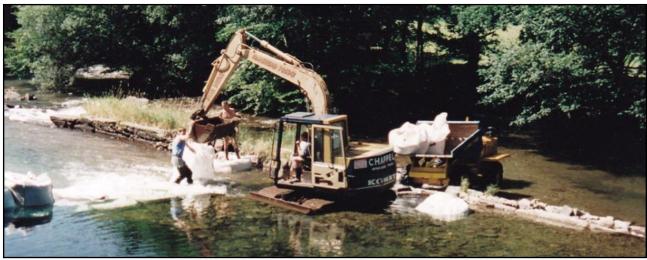
2000 works in progress – damming of the weir pool

The second section of masonry stepped weir was constructed in 2000 to remedy a breach of the original structure. It was built to replicate the adjacent section.

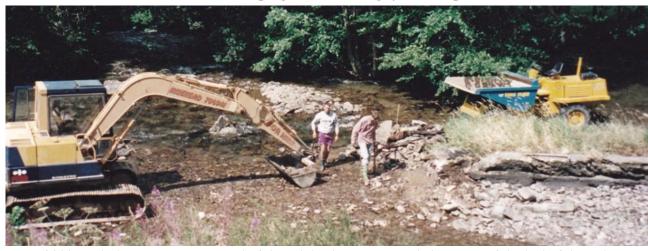
2000 works in progress - removal of the original structure and clearance of the bed of the weir

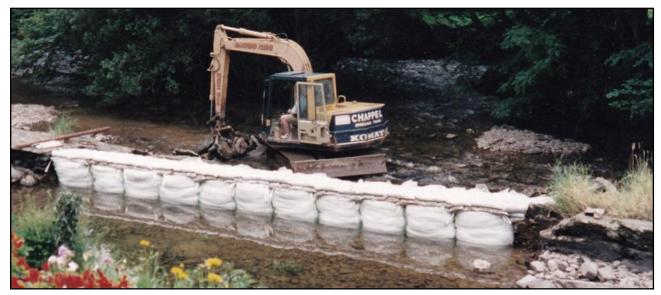
2000 works in progress – substructure of 'dumpy bags' containing dry concrete mix

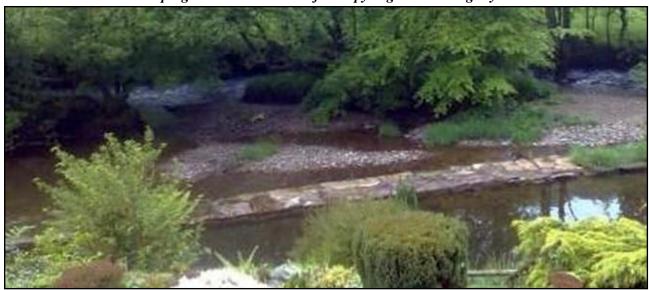
The second section of masonry stepped weir in 2008

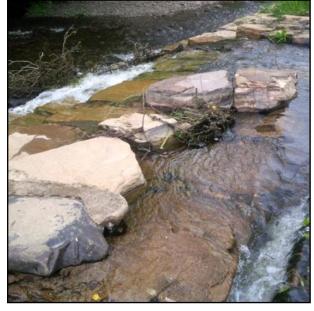
Stones are washed away from the crest

Photographs taken in the present day (below) show the distressed state of this part of the weir.

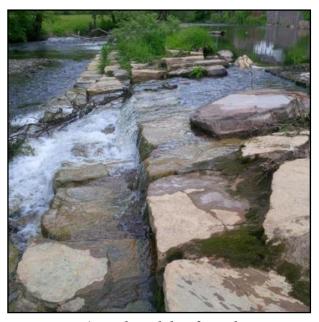
A new breach has formed

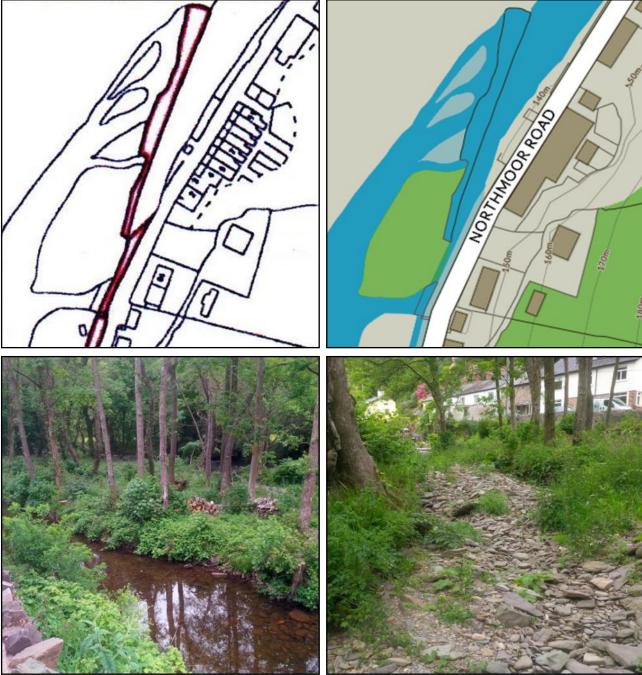
It is evident from Ordnance Survey maps and the Land Registry Title Plan (below) that about half of the east bank of the island was also part of the weir, as shown on the plan (left) by the red line. The plan also shows the dried-up channel almost bisecting the island with a green line. In the 1990s the leat channel was dredged, and the spoil dumped on the east bank of the island. There is a strong likelihood that beneath the spoil will be found evidence of a continuation of the ancient structure of the weir.

The dried-up channel across the island

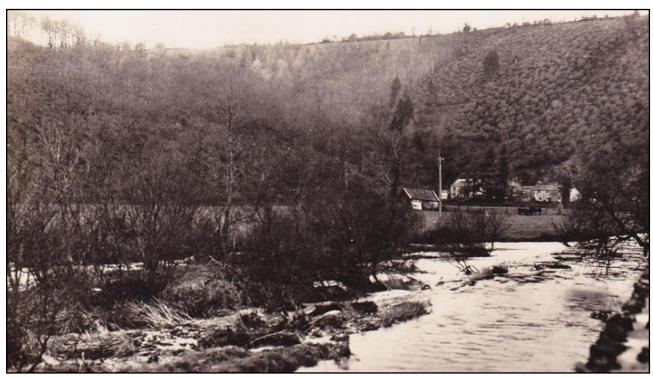
1930s postcard entitled "Weir Stakes and Cleeve"

In the foreground a channel can be seen flowing into the island. An elderly resident recalled that many people in Dulverton referred to the weir as "The Stakes"

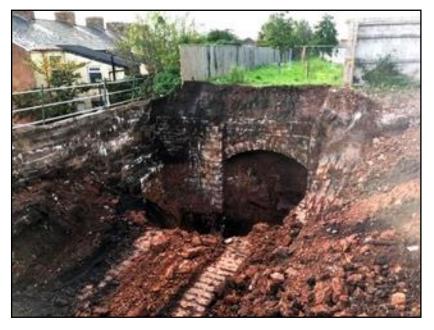
Canal Lift at Firepool, Taunton

Chris Webster at SHER has provided a photograph of the excavated front wall arch of the Taunton Lift. I visited the site, armed with a bundle of plans, maps photos. The contractors. Willmott Dixon, expressed a lot of interest and invited me to look around. All that was visible was part of the front wall. I am now awaiting a copy of the report from Cotswold Archaeology, who had already left the site, before making further comment.
