Report on Excavation for the Dulverton Weir Project 2022

by Nigel Dymond (NDAS)

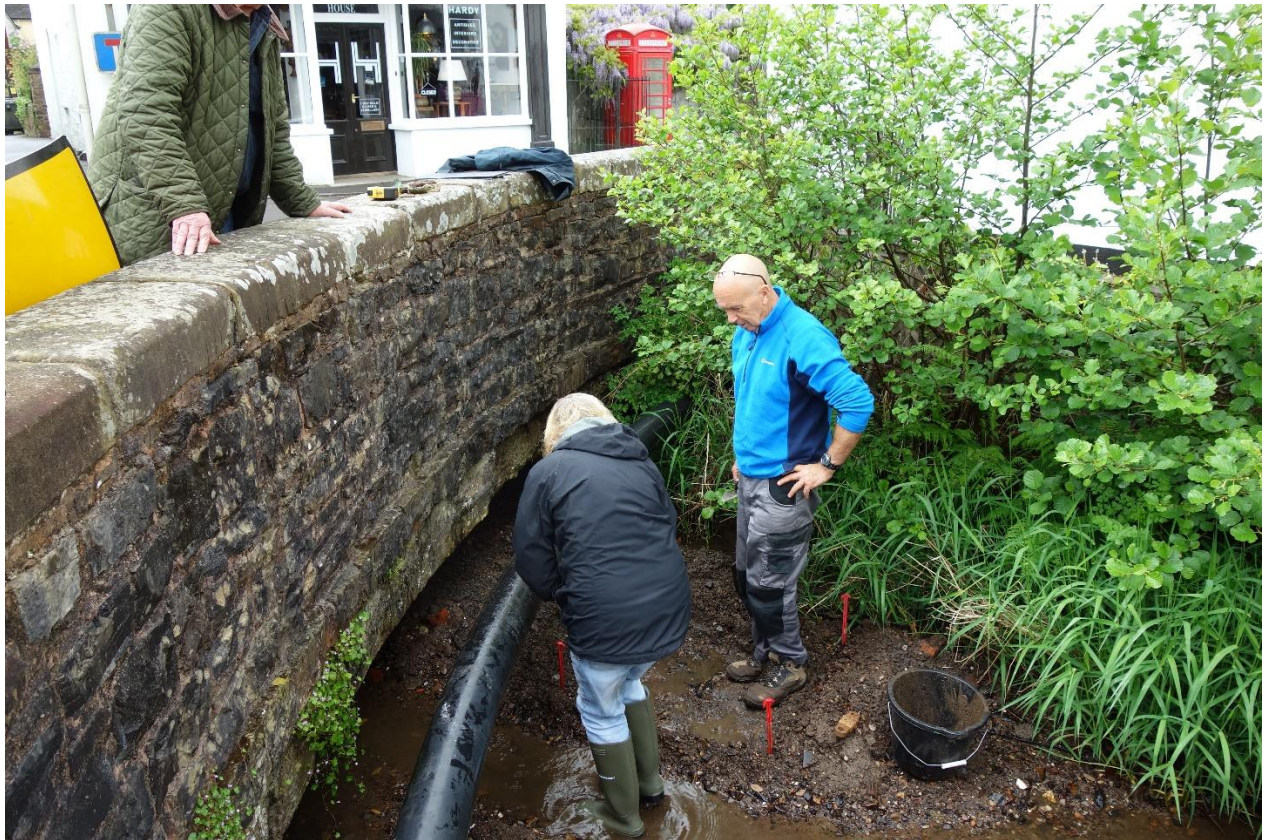
Figure 2 – Marking out the trench.

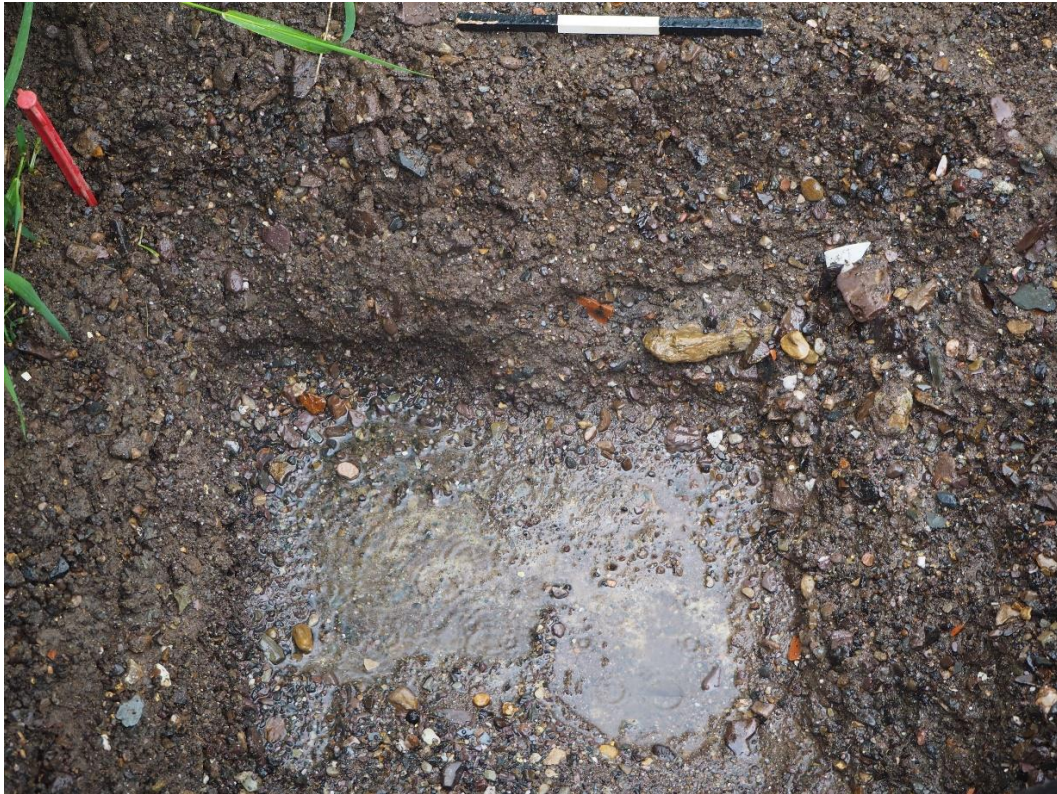
The top layer (300) of the deposits over the leat floor comprised of small pieces of natural gravel and small stones – brown, black and white. Beneath this was (301), a layer of more compact mid brown/grey silted clay, containing water borne pebbles 1cm to 5cm. Finds included coins (all decimal), broken glass (mainly broken bottles), a piece of ‘Bridgewater’ roofing tile, sherds of pottery, ceramic beads from a modern bracelet/necklace (Fig. 7) and part of a brick (manufactured). Beneath this was (302) a reddish-brown silt layer which still contained modern finds: decimal coins, broken bottle glass and ceramic beads. Beneath this was (303) the lime mortar base (with stone inclusions) of the leat. The base had been covered by approximately 30cm of silt (Fig 3).

Figure 3 – Showing the floor of the leat. Scale = 30cm

The lime mortared base of the leat at this location was something of a surprise. Previous reports had suggested it was cobbled, although this may have been a description of the stone inclusions in the mortar. The lime mortar suggests a later resurfacing of the leat base and in general, its use in Devon suggests a post-medieval date.

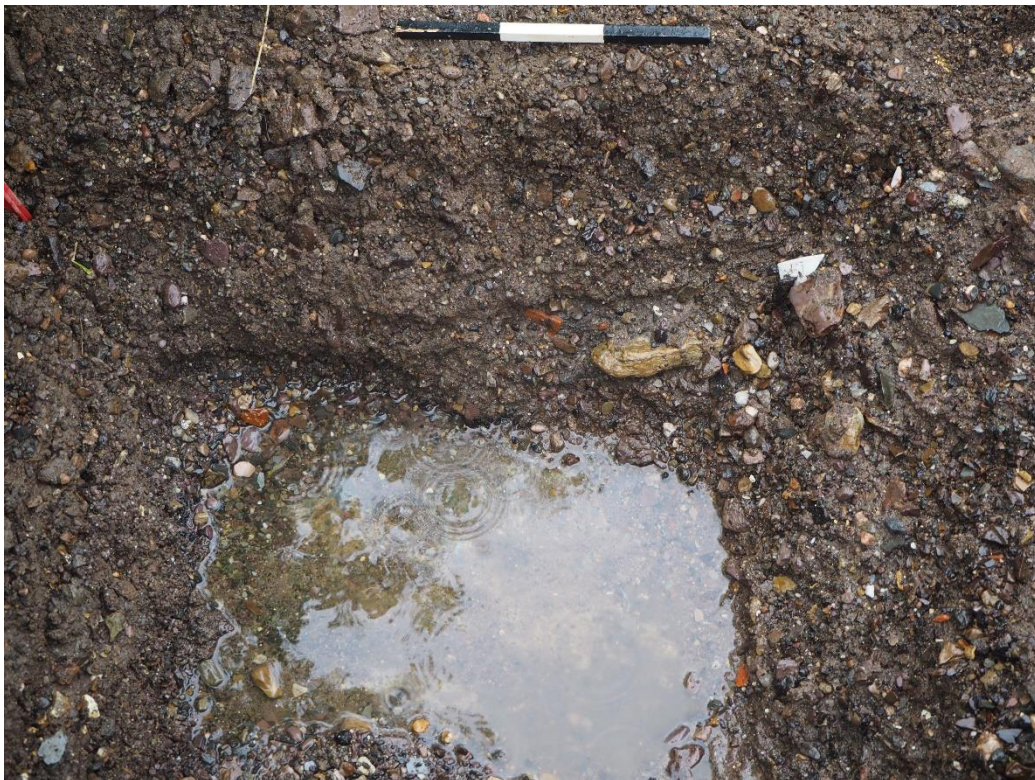
Figure 4 – This photo was taken approximately 30 seconds after the one above (Fig 3) and illustrates the rate that water was ingressing into the trench.

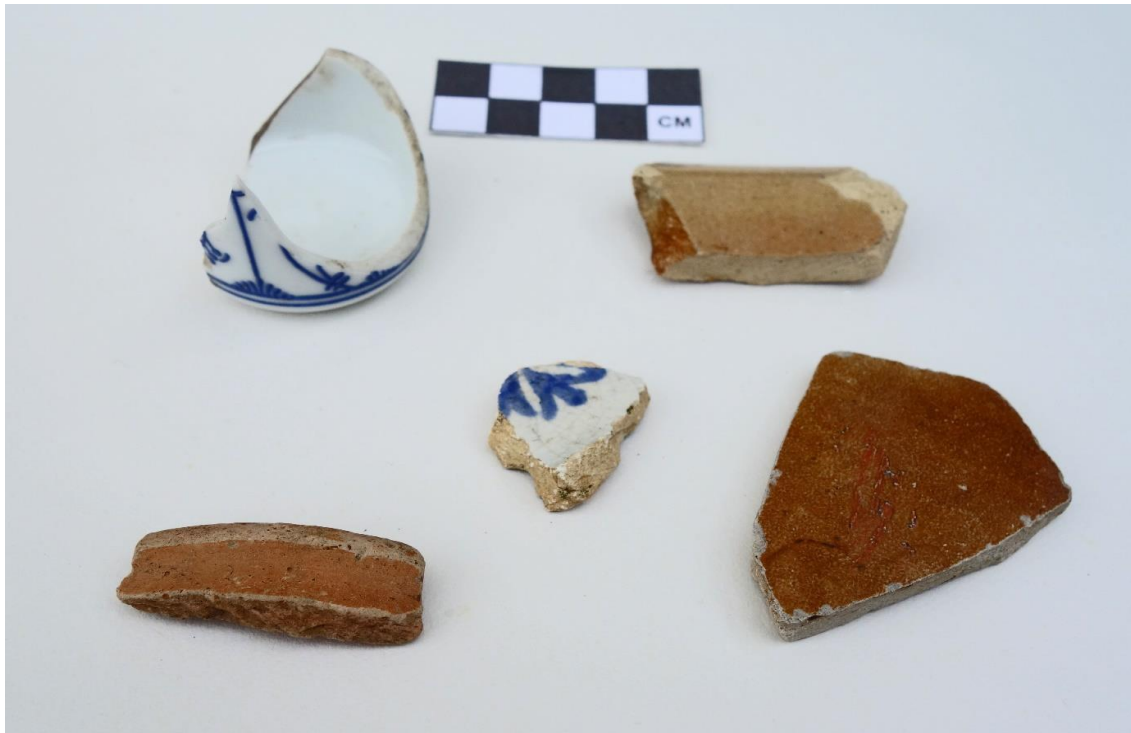
Figure 5 – A selection of pottery recovered during the excavation.

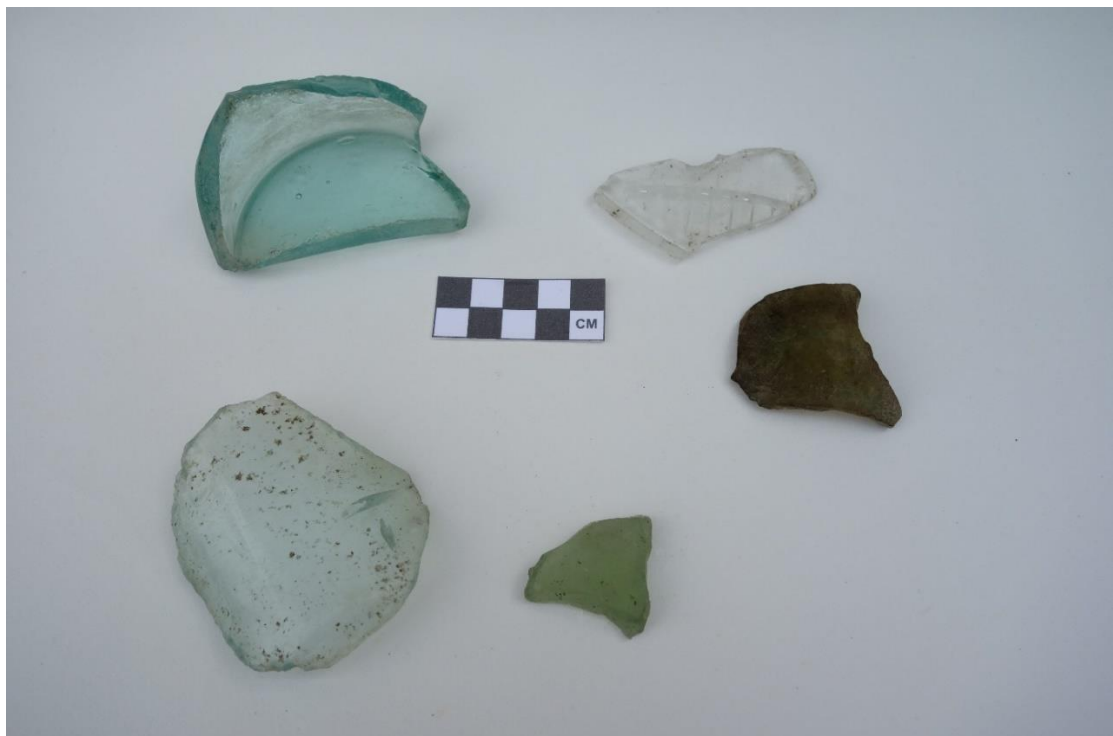
Figure 6 - Selection of broken glass recovered during the excavation. The broken bottle base (top left) is embossed 'SWC Co') and the broken car headlight lens (top right) is embossed 'Right hand drive'.

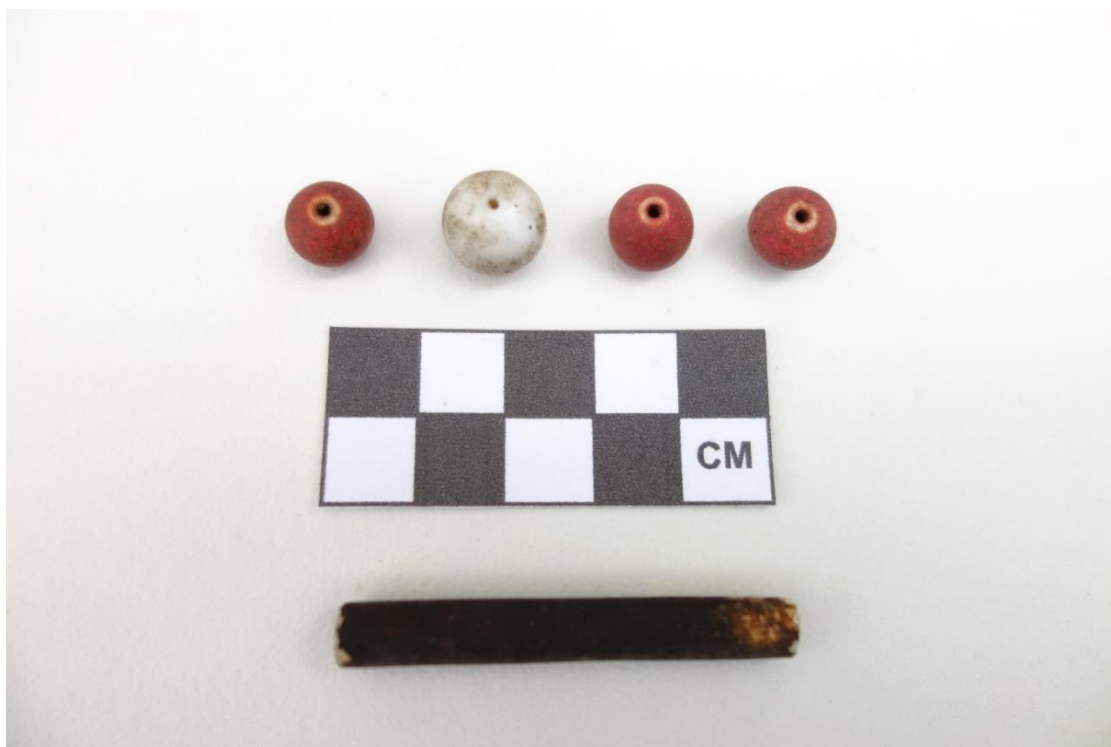
Figure 7 – Ceramic beads recovered during the excavation.
