# DULVERTON WEIR

**A report by Dulverton Weir and Leat Conservation Group  
on the history, structure and condition of Dulverton Weir**

## Background

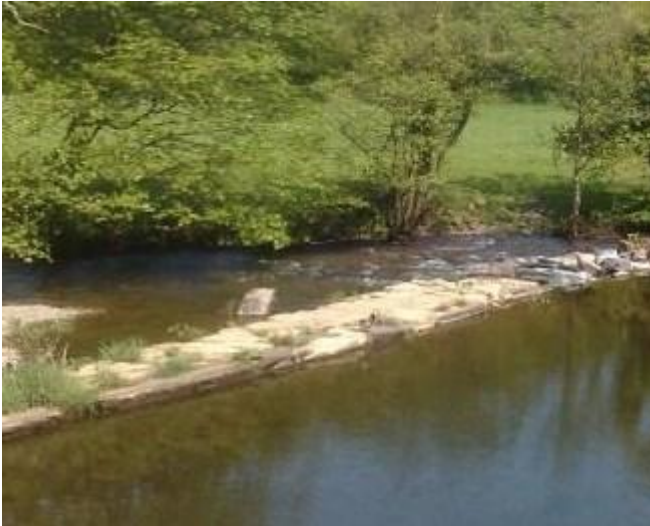
View from above

This is the first part of stepped masonry weir that was constructed in the late 20<sup>th</sup> Century to replace damaged original structure. The material is yellow sandstone cut mainly in triangular blocks and joints filled with mortar. Later patchwork has been done using concrete. It is not a solid masonry structure; the core was filled with stones from the riverbed.

This section of weir is in poor condition for the following reasons:

1. Stones are missing from the crest.
2. Seepage through the joints of the remaining crest stones will eventually wash out the joints.
3. The void in the core makes the structure inherently weak.
4. There are reports from canoeists of canoes getting "pinned" under the masonry by the fish pass which suggests that the footing has been eroded.

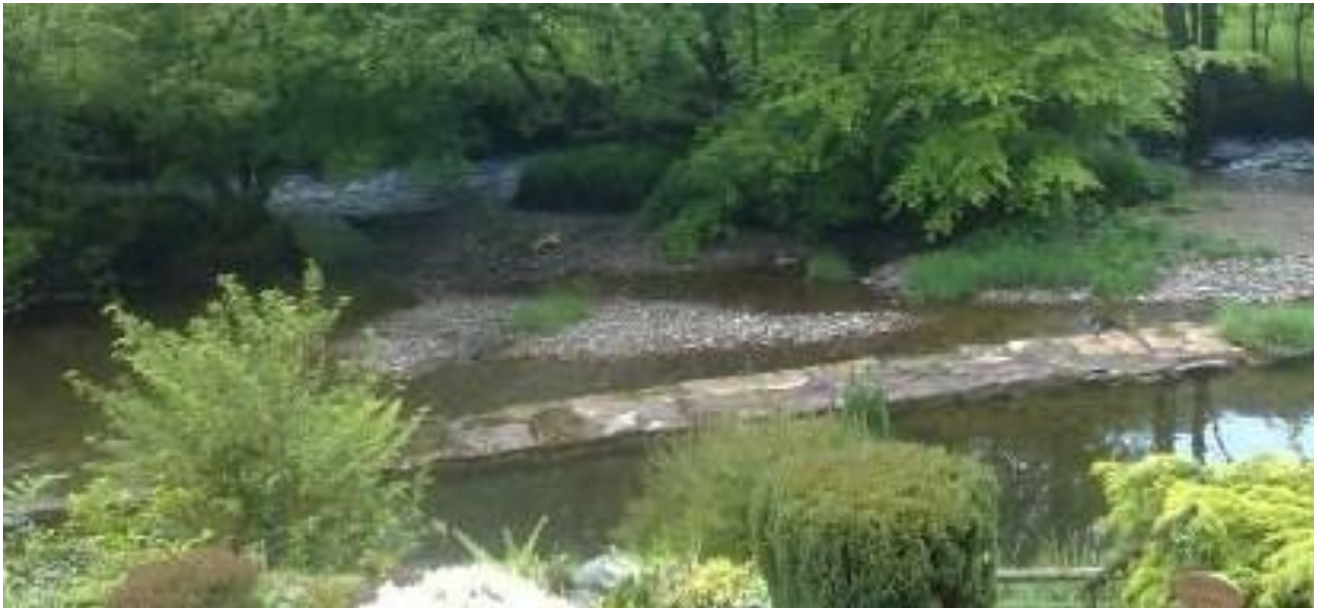
The photo above, taken in 2008, shows the second section of masonry stepped weir. It was constructed in 2000 to remedy a breach of the original structure in 1999. It was built to replicate the adjacent section.

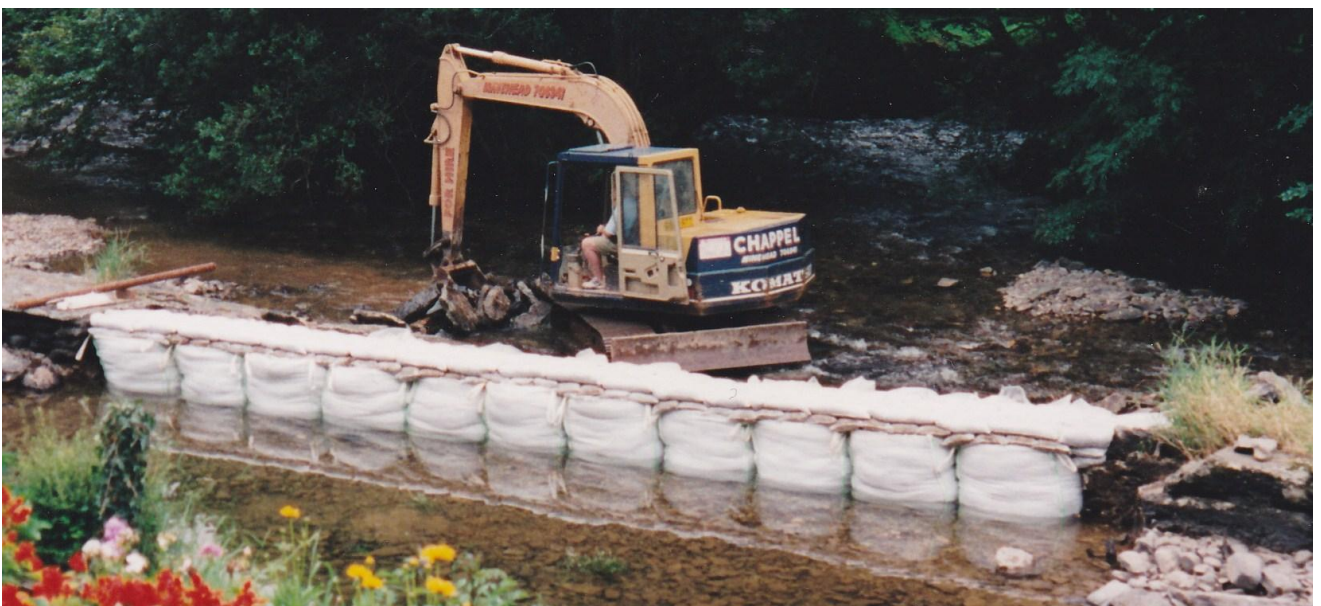
2000 works in progress – substructure of 'dumpy bags' containing dry concrete mix.

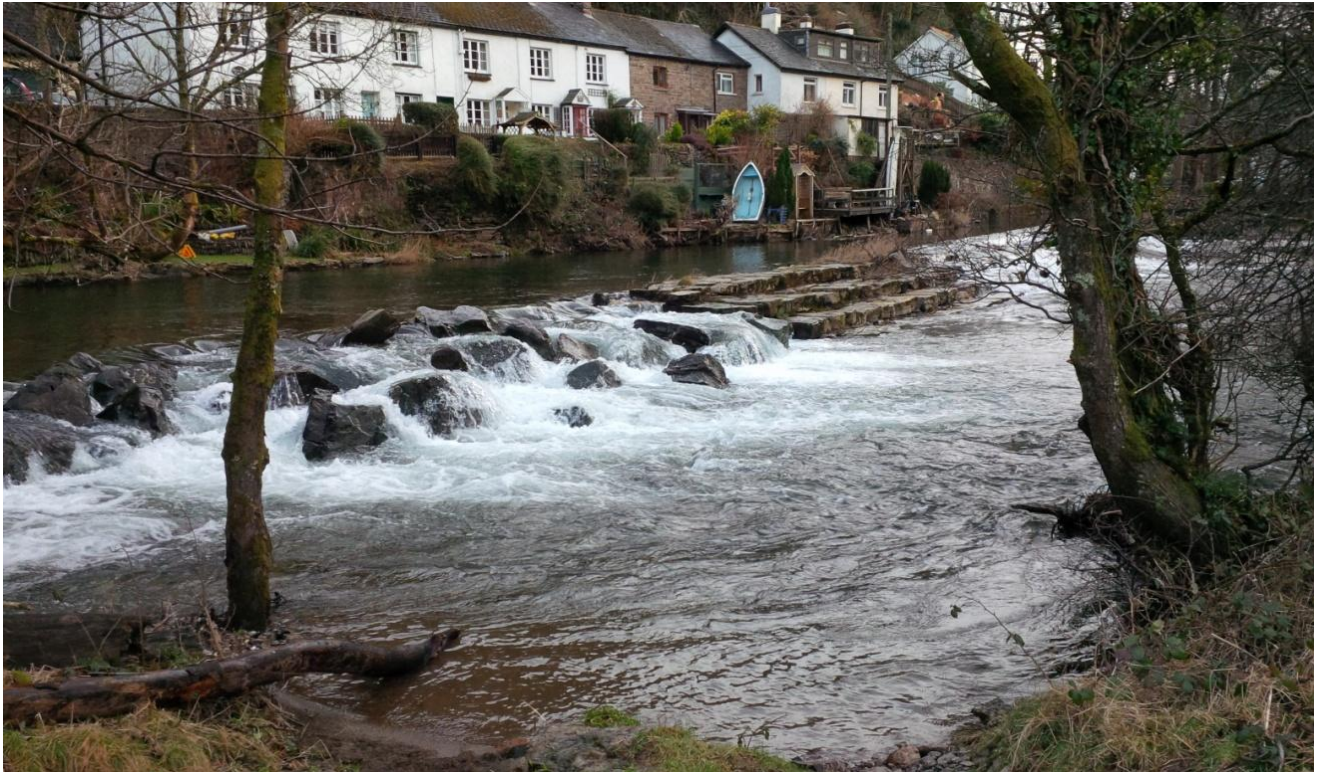
What we know today as the fish pass was built in 1993 to remedy the collapse of a section of the original structure of the weir that had caused the water level to be too low to feed the leat, thereby preventing the Dulverton Laundry from extracting water. The fish pass comprises a number of boulders laid roughly along the bed of the original weir. The work was carried out by local contractor, John Pugsley, who sourced the boulders from the riverbed.

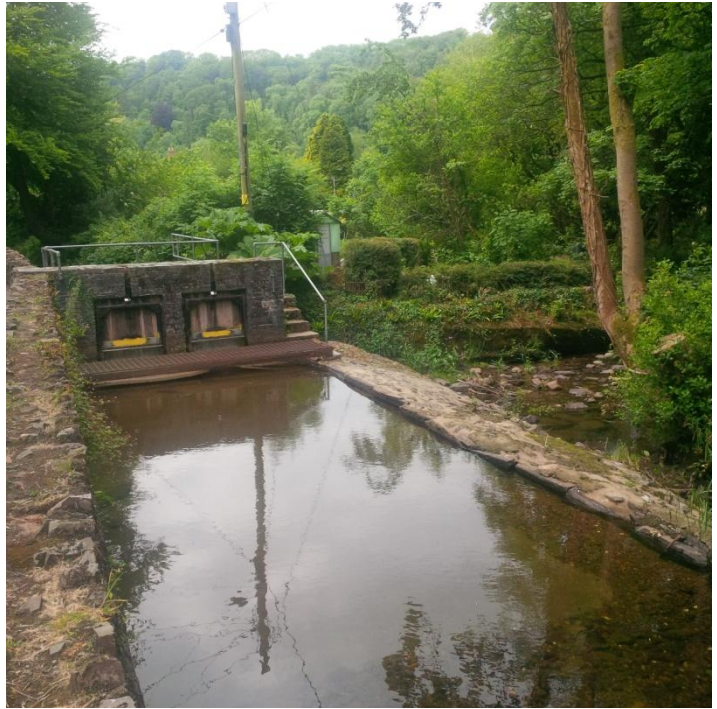
Photo of the side weir

Previously reconstructed when the sluice was rebuilt around 1999, the side weir had become damaged over time resulting in the need for remedial works by 2011.

A first attempt failed due to the use of non-waterproof cement so the present structure is a second reconstruction done in 2012.

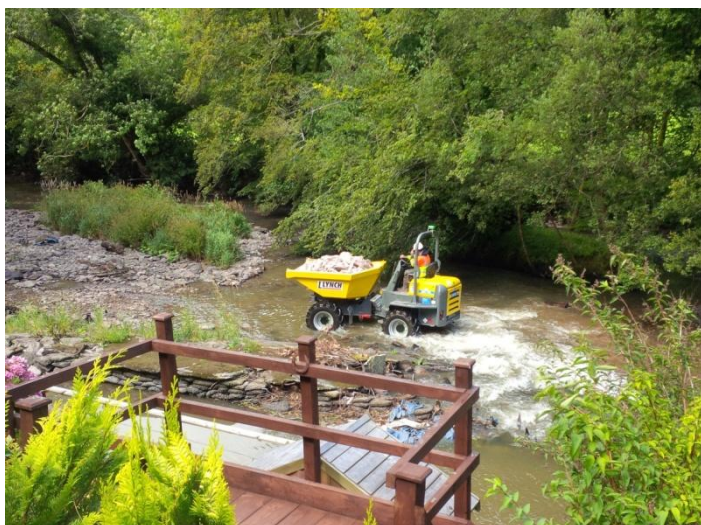
An estimated 25 tonnes of stone was brought in from outside the area to fill the gabion baskets.

The stone was dropped in the gabions by mechanical shovel and the breach was filled with dumped stone from the riverbed.

Photo showing stone being brought in by dumper

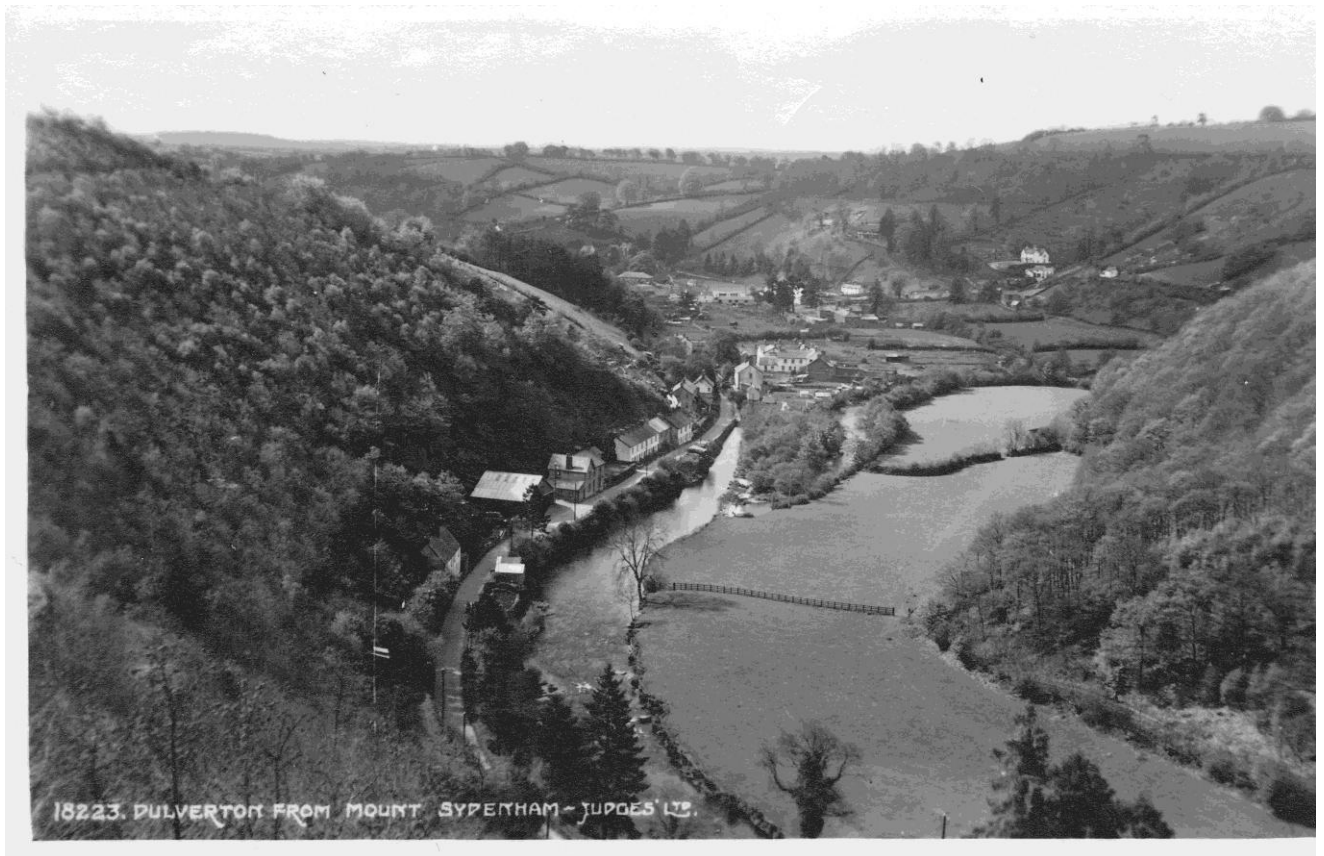
View of the weir from Mount Sydenham c.1930
